Technical Advisory Bulletin

To: GAF Residential Sales, GAF Contractors, Field Services, AIS, CARE
From: Technical Services
No: TAB-R-162

Installed Fasteners MUST BE Flush to the Surface

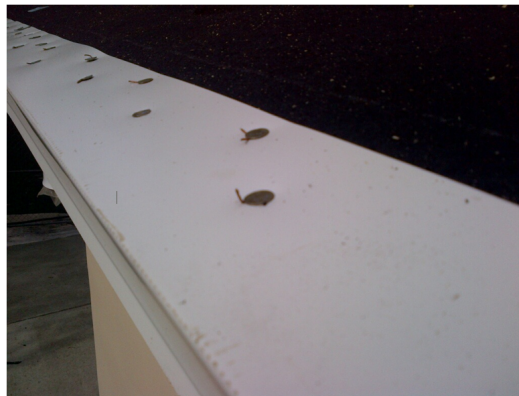
The residual metal “hair” that is left on the fastener head after being shot from a pneumatic coil nail gun can cause damage to your newly installed roof. All installed fasteners **must be** flush to the surface. Failure to provide a suitable surface for subsequent material installation is not in accordance with GAF requirements.

As shown in Fig. 1 below, the metal “hair” can be long and sharp enough to puncture or cause damage to installed asphalt shingles.

Figure 1: Residual metal “hair” at drip edge

Hammer the “hair” left on the installed fastener flush the surface so that nothing will puncture or damage what is being installed on top.

- Notify your fastener manufacture, supplier and/or local code authority if you are encountering this issue.
