# Proceedings

IIBEC 2022 - Building for the Future

# Proceedings of the IIBEC International Convention and Trade Show

# Nondestructive Testing Methods in Structural and Building Enclosure Assessment

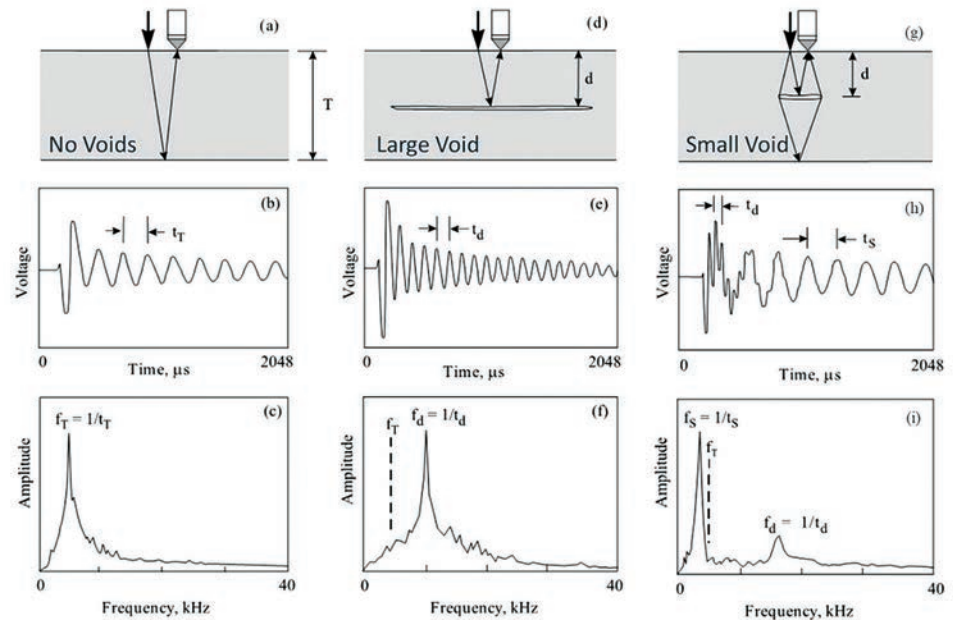
**Figure 4.** Sample of impact-echo signals for a thin element with no voids (a, b, and c); a thin element with a large defect (d, e, and f); and a thin element with a small void (g, h, and i).  $T$  = thickness;  $d$  = depth to flaw;  $t_T$  = characteristic period of full thickness echo;  $t_d$  = characteristic period of partial thickness echo;  $t_s$  = characteristic period of full thickness echo around a flaw;  $f_T$  = thickness frequency;  $f_d$  = thickness frequency at flaw;  $f_s$  = shifted full-thickness frequency. (Adapted from Sansalone and Street, 1997.<sup>2</sup>)

The impact-echo technique is based on the use of transient stress waves generated by a short-duration elastic impact of a small steel sphere on a concrete, masonry, or asphalt surface. This impact generates low-frequency stress waves that propagate into the structure and are reflected by flaws, external surfaces, or both. Surface displacements caused by the reflections of these waves are recorded by a displacement transducer located adjacent to the impact. The resulting displacement-versus-time signals are transformed into the frequency domain, and plots of amplitude versus frequency (spectra) are obtained. Multiple reflections of stress waves between the impact surface, flaws, and other external surfaces give rise to patterns of wave reflection and transient resonances, which can be identified in the spectrum and used to evaluate the integrity of the structure or to determine the location of flaws. It is the patterns present in the waveforms and spectra that provide information about the existence and locations of flaws or the dimensions of the cross section of the structure where a test is performed, such as the thickness of a concrete pavement. If flaws such as cracks, voids, or delaminations are present, these patterns are disrupted and changed in ways that provide qualitative and quantitative information about the existence and location of flaws. **Figure 4**<sup>2</sup> provides examples of typical signals for element with and without voids.

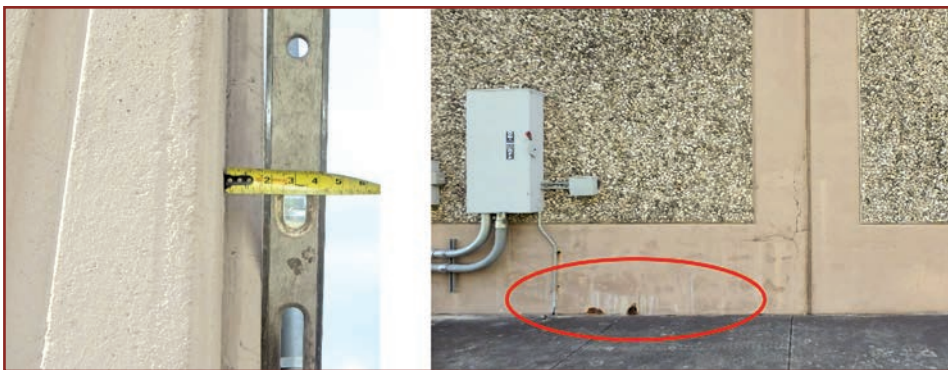
Figure 10. Extent of visible wall bowing (left) and efflorescence at crack in panel (right).

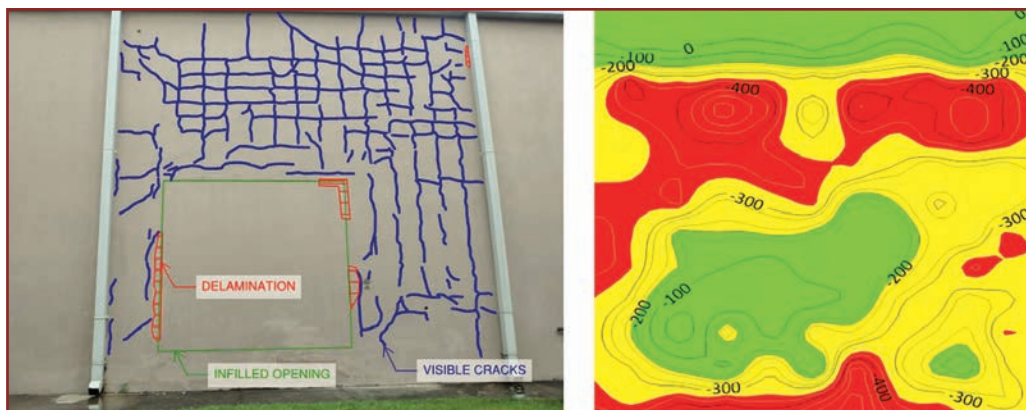
**Figure 13.** Annotated photograph of wall panel at exterior (left), and half-cell corrosion potential contour map (right). In the map, red and green areas have the greatest and least probabilities for corrosion, respectively, and yellow areas represent corrosion probabilities between those of the red and green areas.

The chloride ion content of the cores removed from the facade panels was also tested. Specifically, the cores, which were removed from the entire thickness of the panels, were subdivided into smaller components. By subdividing the core, chloride content in various segments can be measured, and comparison of those chloride contents can provide information as to their source. For example, a structure exposed to deicing salts would have an elevated chloride content at the exterior face with a much lower chloride content at an interior face.

(ACI 222R-19).<sup>11</sup> The measured chloride ion contents in the samples removed from the structure ranged from 190 to 1550 ppm. Additionally, the chloride content throughout the panel thickness was fairly uniform, which suggests that chlorides were mixed in with the fresh concrete.

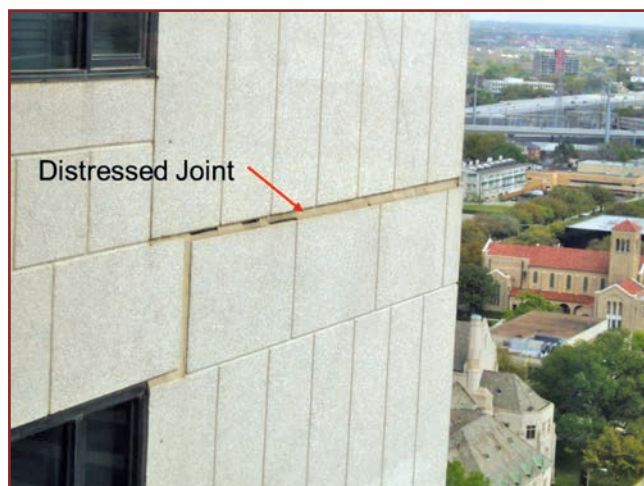
**Figure 14.** Apparent panel movement at a joint.

One of the homeowners within the condominium building reported a visible increase in a joint between adjacent facade panels near their unit on the 20th floor, which suggested that a concrete facade panel had shifted. Given the information provided, an emergency response team was quickly mobilized to site to observe the conditions and assess potential life safety concerns.

Upon arriving on the site, we observed the distress shown in **Fig. 14**. We advised the client to immediately barricade the area below this panel to prevent injury to anyone on the

building plaza level below. A contractor was quickly mobilized to temporarily stabilize the affected panel using the lifting elements that had been used to lift the panels during the original construction of the building. With the immediate hazard temporarily addressed, assessment of the panel movement began.

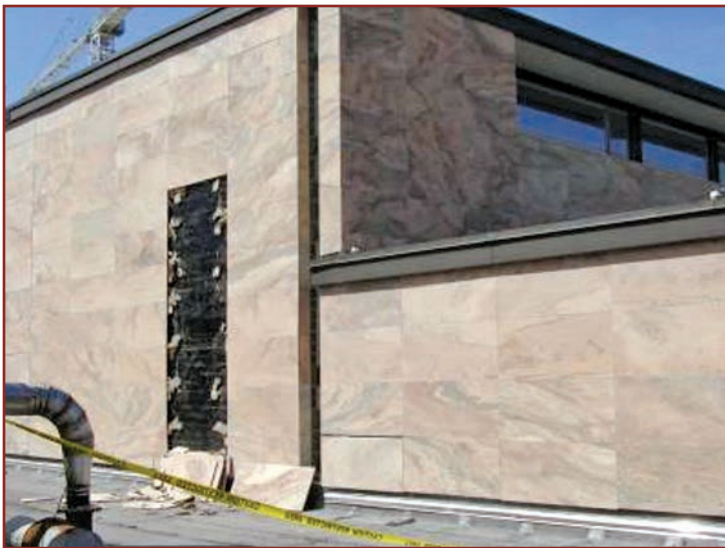
**Figure 17.** Area of panel detachment.

After the building had been in service for more than 50 years, seven marble panels detached from the south face of an exterior penthouse wall and fell onto the roof of the building (Fig. 17). We were tasked with conducting an assessment program to first evaluate the immediate life safety concerns and then comprehensively evaluate the hand-set marble panel cladding system. Based on our initial response and site assessment, we recommended overhead fall protection at all pedestrian areas to mitigate risk posed by potential systematic concerns with the panel support system.

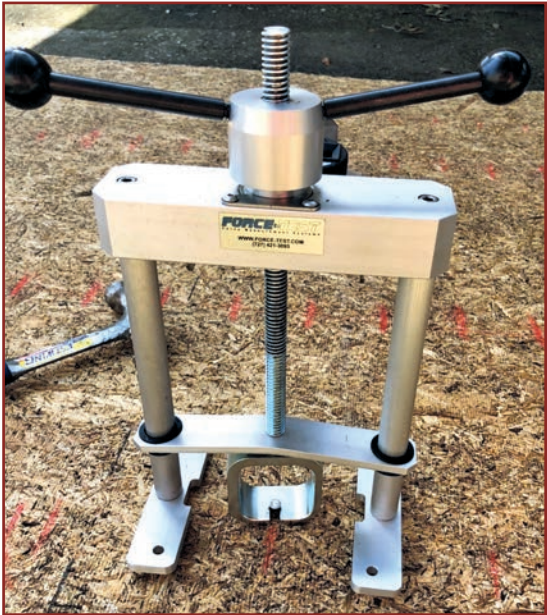
Figure 1. View of a fastener being extracted from an oriented strand board panel with a digital pull tester.

Testing was conducted in three phases. The first phase tested fastener withdrawal only from a variety of substrate conditions with no lath present. The second phase pull-tested samples of lath attached to the substrates with the same types of fasteners used in the first phase. ASTM D1761, *Standard Test Methods for Mechanical Fasteners in Wood*,<sup>10</sup> was used as a guide for fastener and lath testing. In the third phase of testing, full-scale stucco panels were constructed using the previously tested

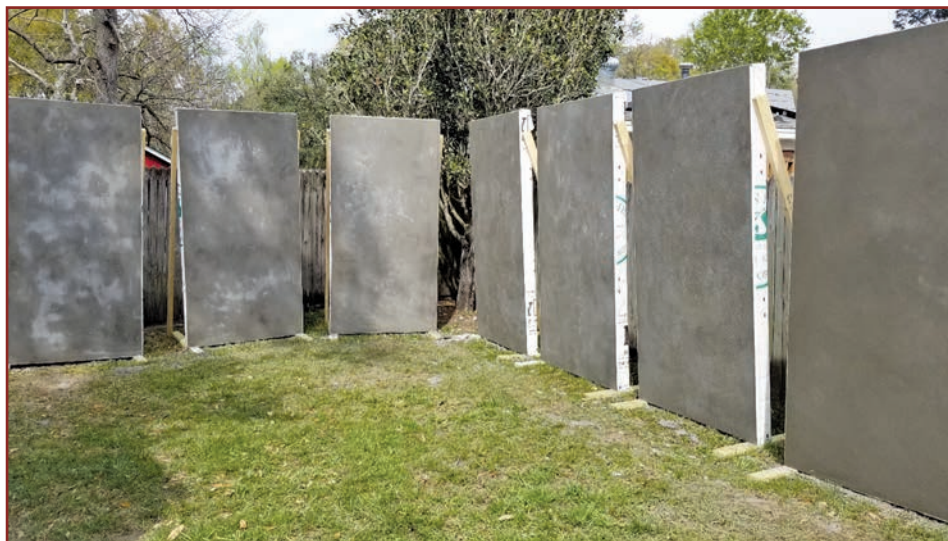
*Figure 3. The arrangement of several stucco panels during initial curing.*

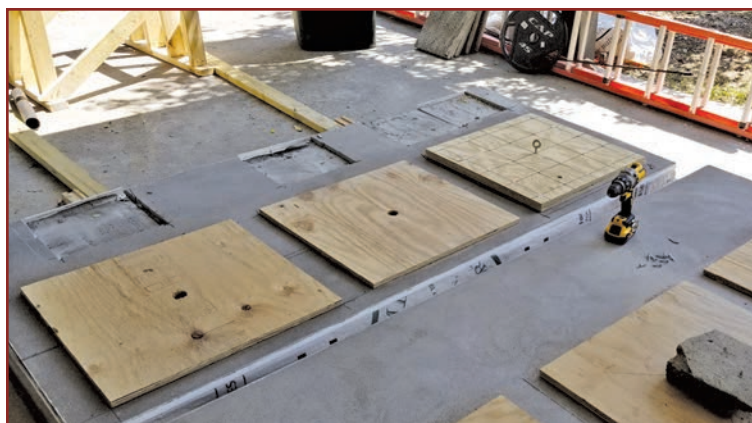
Figure 4. Stucco panels being prepared for testing. The panels were removed from the support stands and laid flat. Per ASTM C1860, nine 3/4-in.-thick plywood panels were adhesively attached to the stucco.

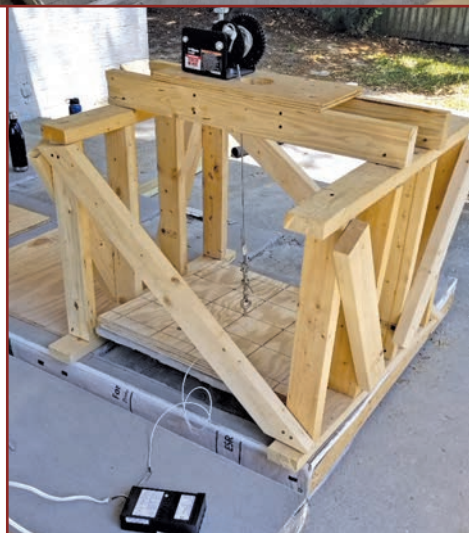
Figure 5. The overall arrangement of the stucco pull-test rig. A worm-gear-driven winch was used to apply tension to a cable connected to an eyebolt in the plywood blank. A 1000-lb load cell was placed in line between the tension cable and the eyebolt.

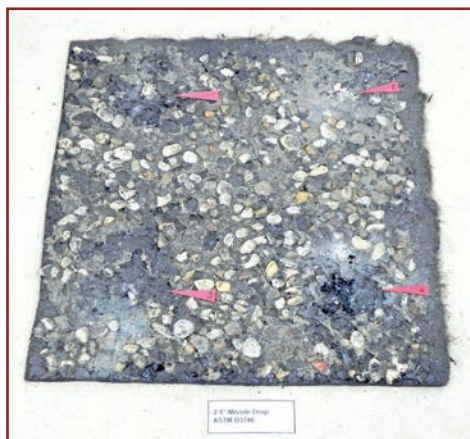
Figure 4. The test sample after the missile drop and after the loose gravel was removed.

The test results related to surface damage were consistent. The impact from a 2.5 in. (64 mm) missile resulted in surface damage to the samples on both the insulated and noninsulated substrates. The results of the laboratory impact damage to the surface were compared with test samples of roofs that had been damaged by hail and to examples included in Haag Engineering's *Built-up Roofing: A Pictorial Guide*.<sup>8</sup> The test sample before the missile drop is shown in Fig. 3. The test sample after the missile drop and after the loose gravel was removed is shown in Fig. 4. The red arrows identify the area of impact in Fig. 4.

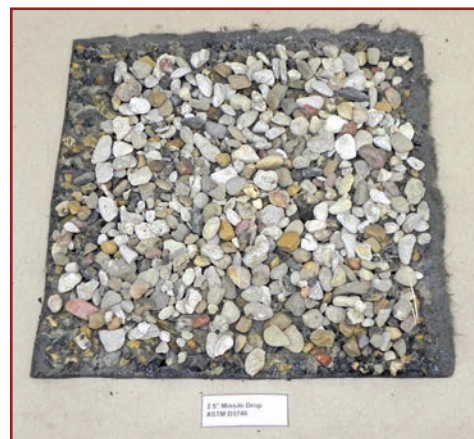
Figure 3. The test sample before the missile drop.

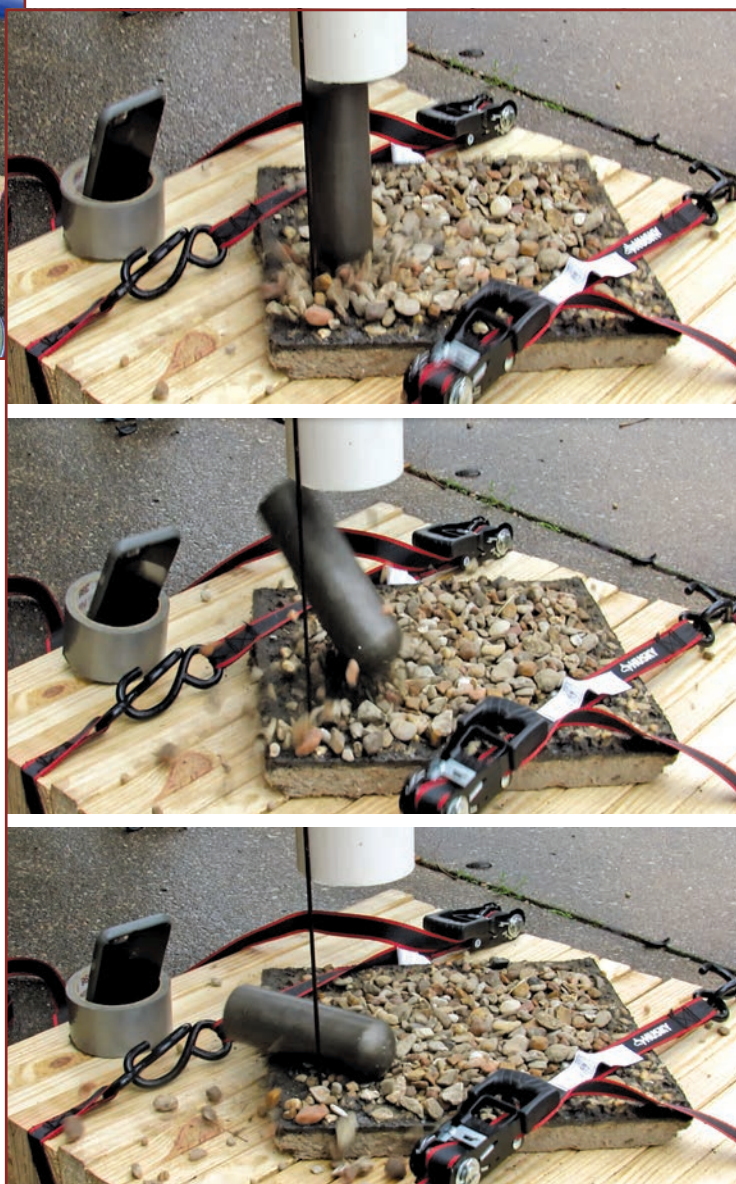
Figure 5. The test sample after the missile drop showing crushed gravel at point of impact.

The areas of impact were very similar on all tests. There was a general displacement of the imbedded aggregate and exposure of the asphalt flood coat. The aggregate at the point of impact was crushed at some of the impacts (Fig. 5). In no case did the impact result in aggregate being driven into the sample, affecting the felts below. The crushed aggregate was likely the result of using a steel missile rather than an ice ball for testing, as hail typically shatters on impact and steel does not.

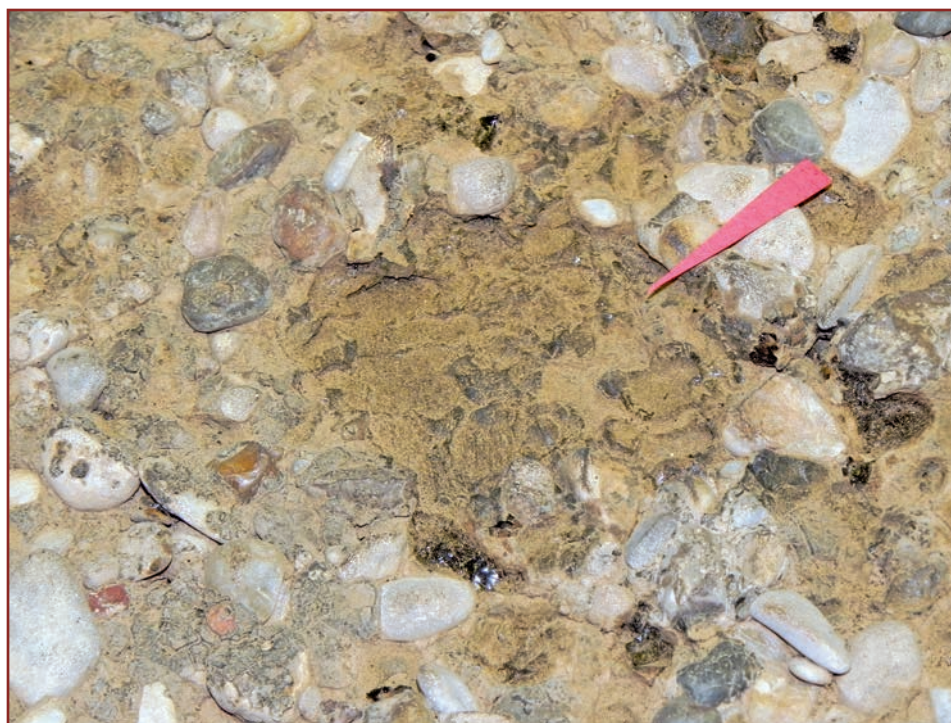
Figure 7. A test sample taken from a roof that was damaged by hail.

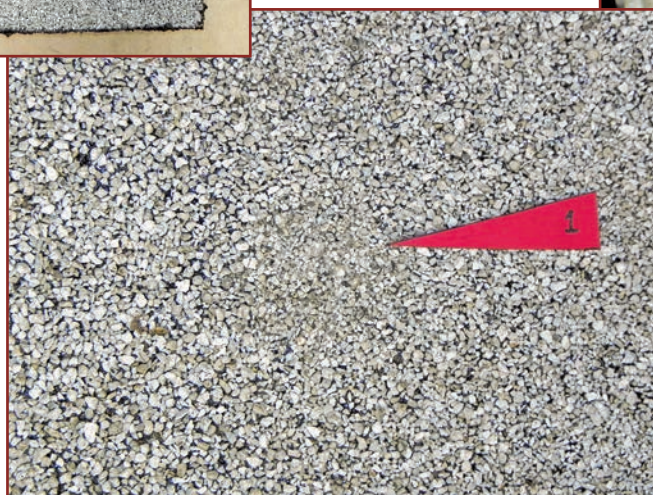
**Figure 19.** A closer view of impact area 1. There is a slight difference in the color of the granules.

**Figure 19** shows a closer view of impact area 1. There is a slight difference in the color of the granules.

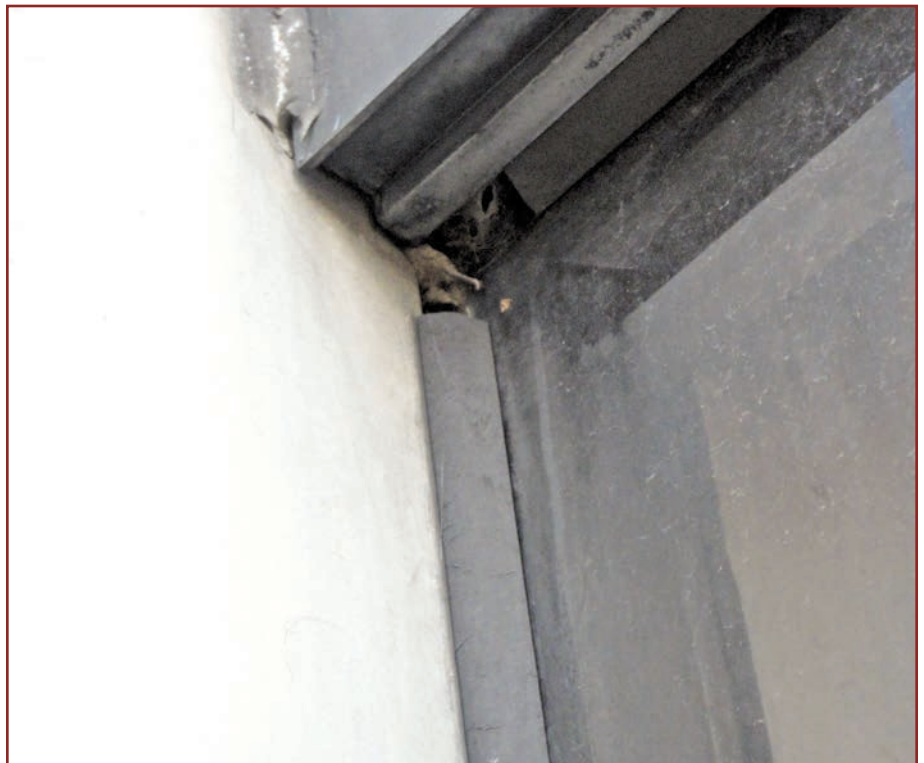
Figure 8. Example of gasket cracking deterioration in a 1965 curtainwall.

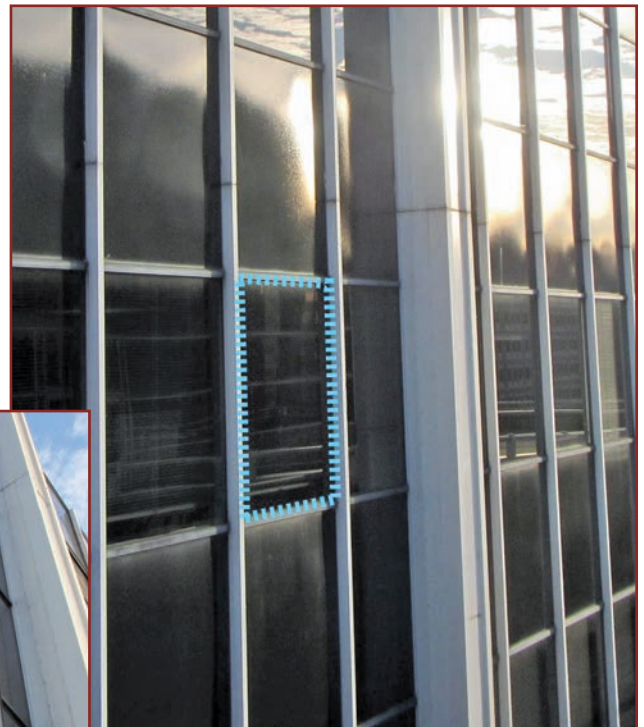
Figure 9. Representative photo of curtainwall glazing panels within the interior wind zone. The blue dashed lines frame the interior zone window analyzed in the case study.

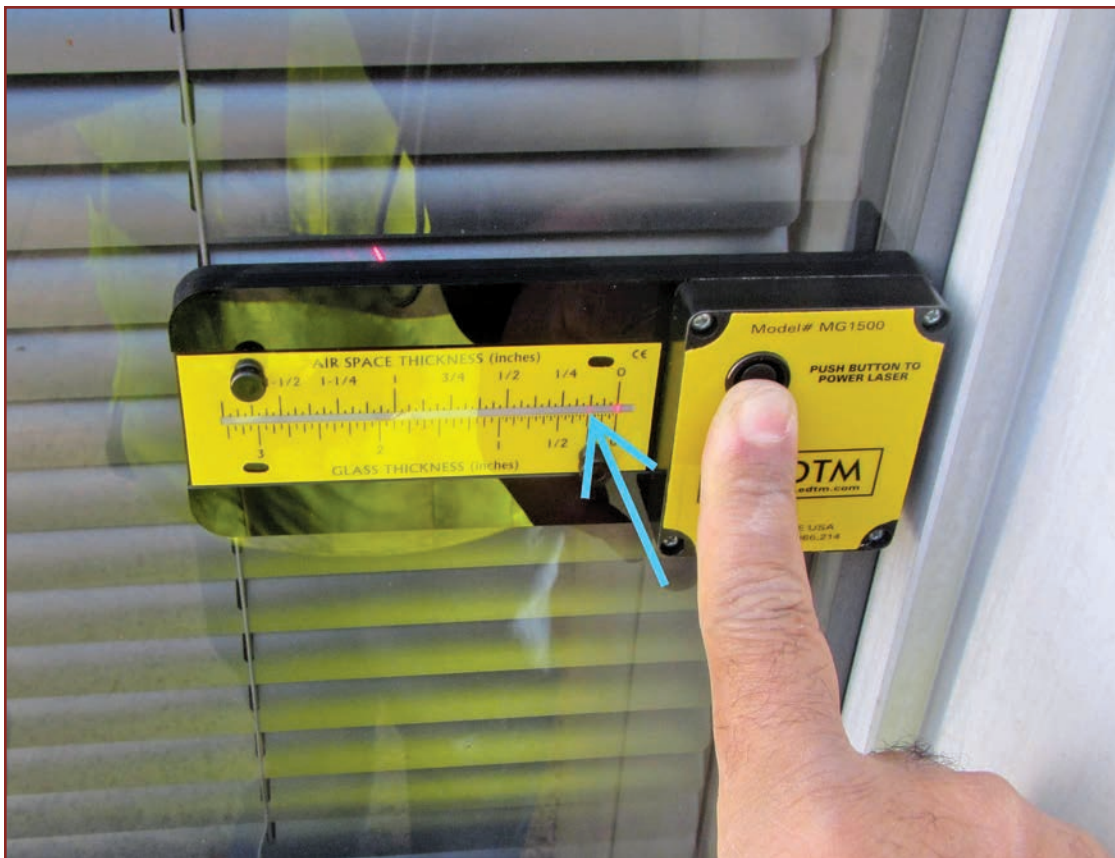
**Figure 11. Glazing thickness measurement (1/2 in.) at curtainwall glazing panels.**

transitions, terminations, and anchorage. A site investigation was necessary to obtain field measurements and collect as-built construction documentation of representative glazing panels. An MIG MG1500 Laser Glass Thickness Gauge was used to measure the cross-sectional thickness of the glazing panels (Fig. 11).

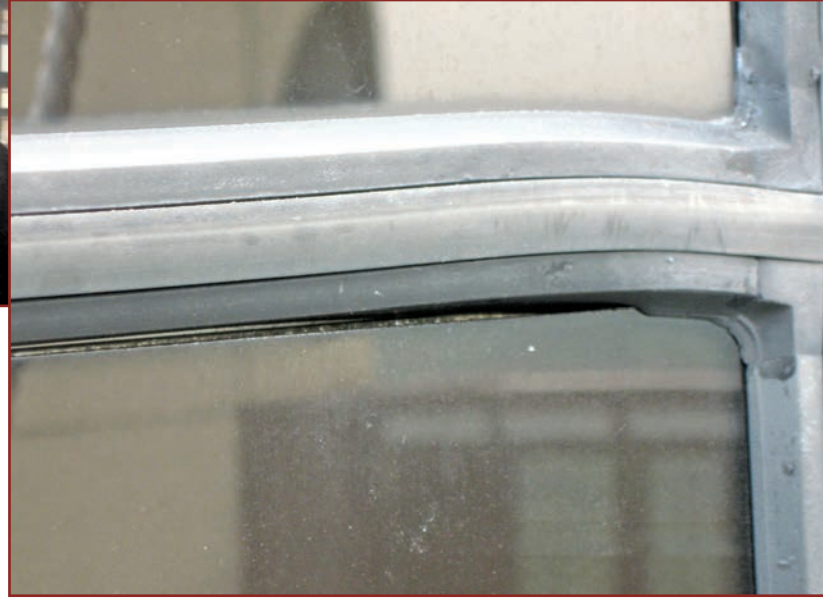
*Figure 4. Dislodged glass below a floor line in an early curtainwall.*

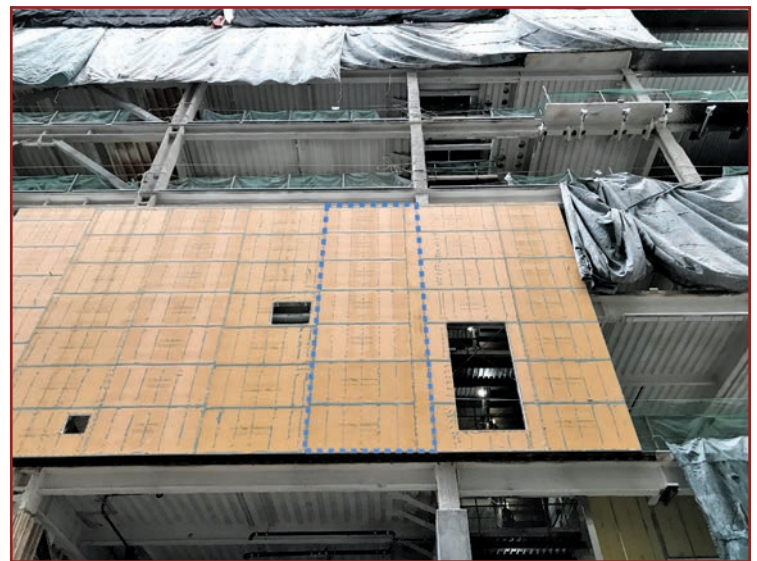
*Figure 5. Large-format panels on a commercial high-rise building. Panel size is indicated by the blue dashed lines.*

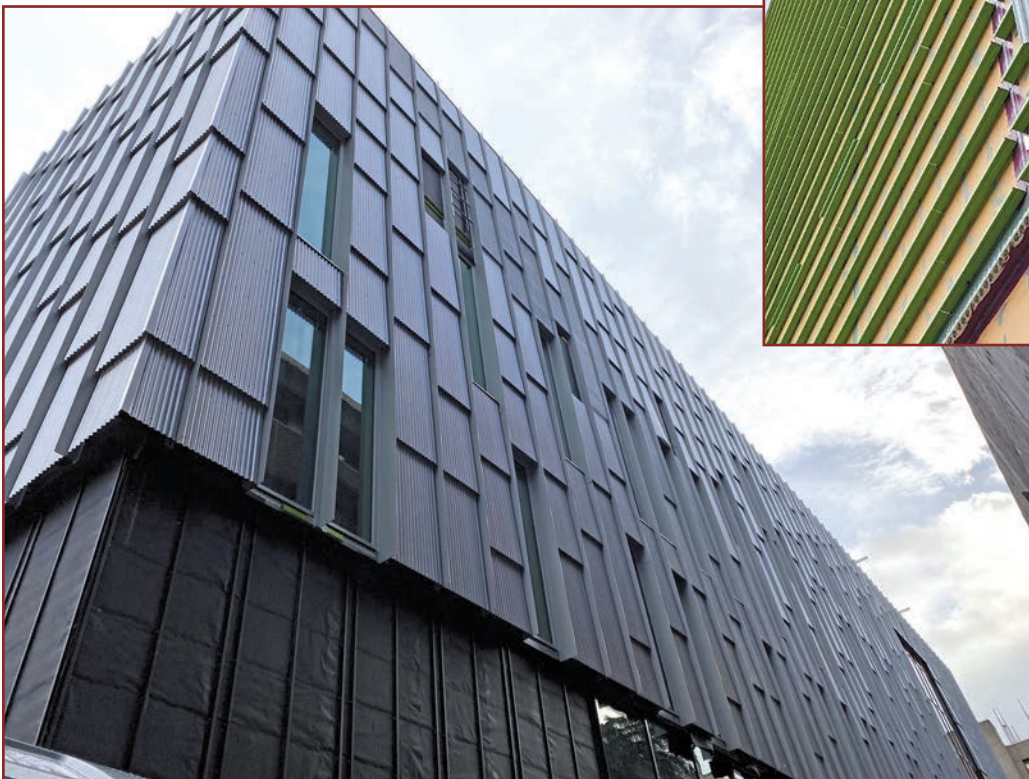
*Figure 11. Panelized wall facade nearing completion.*

All of these steps—from determining the magnitude and directions of movement to laying out the panels and their joints to accommodate the movements, to designing waterproofing and cladding systems that work—are often necessary for the successful execution of a high-performance enclosure (see [Fig. 11](#)).

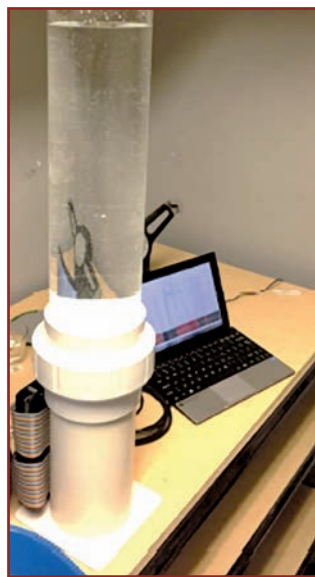
The first consideration is water resistance, where the material—when in contact with liquid water—needs to resist the passage of that water through the material. The most common test is a hydrostatic head test<sup>6</sup> where a 55 cm (22 in.) column of water is placed on the material for five hours (Fig. 3). The underside of the material is checked for drops of water coming out the other side. The limitation in this test is that it seems to work well on thin materials but not on thick materials. If you use this test method on 16 mm (5/8 in.) gypsum boards, there is a good chance that the boards will pass this test as there will not be drops of water on the underside, but the gypsum core may become mush.

**Figure 3. Hydrostatic head test.**

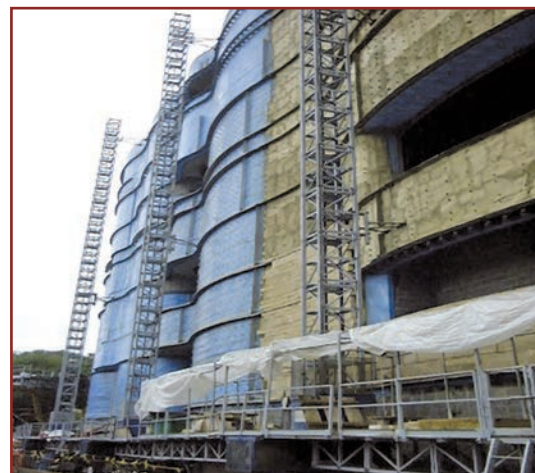
**Figure 4. Air barrier system for six sides of the building.**

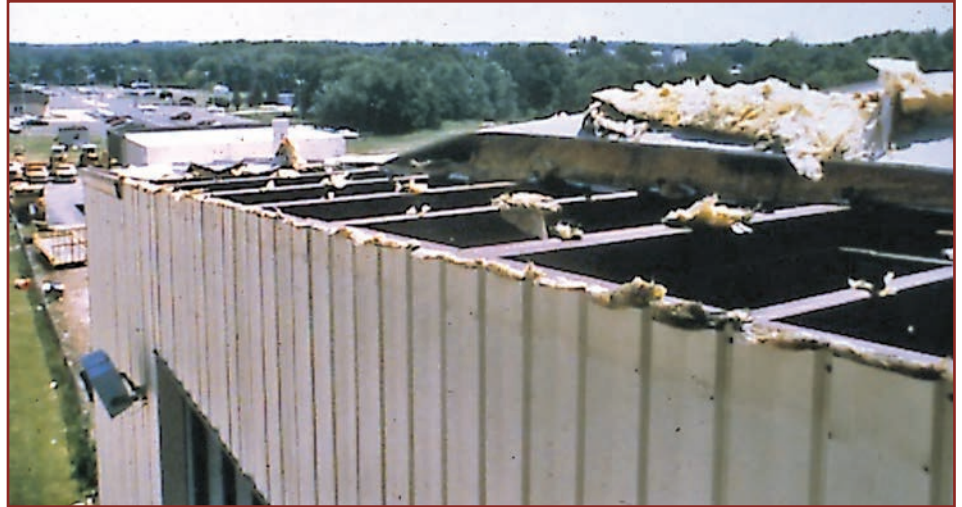
Figure 1. Typical wind failure of a standing seam roof.

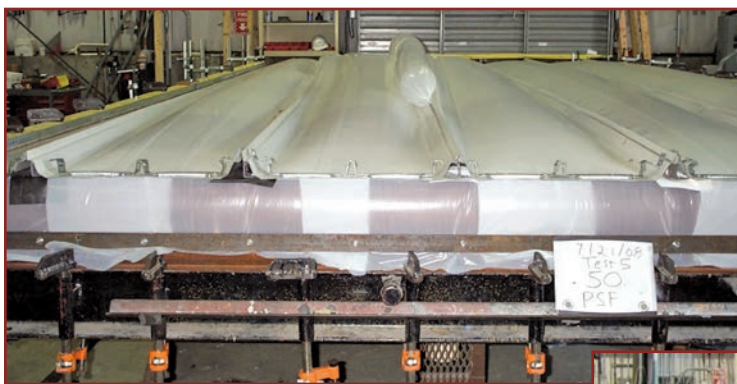
**Figure 5.** Large-scale testing of a standing seam roof (SSR) without external seam clamps (ESCs) (above) and with ESCs that did not fit the SSR properly (at right). Compared with the failure point for the SSR with no ESCs (50 lb/ft<sup>2</sup>), the failure point for the SSR with improperly fitting ESCs only increased by 20% (to 60 lb/ft<sup>2</sup>).

The same SSR type as shown in Fig. 5 was tested again with properly fitting ESC and

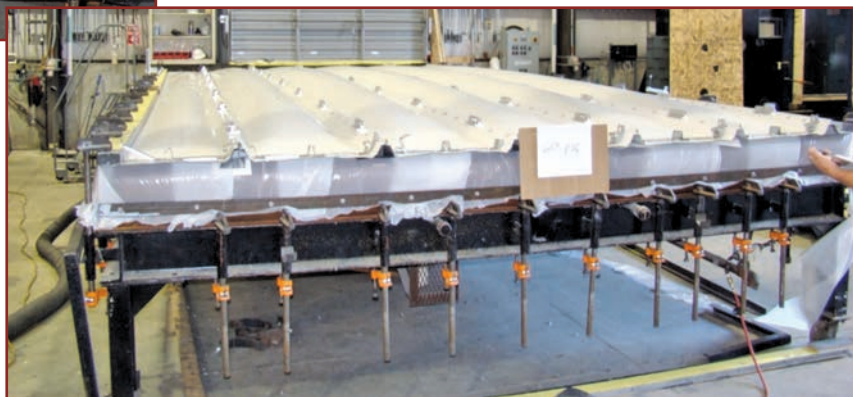
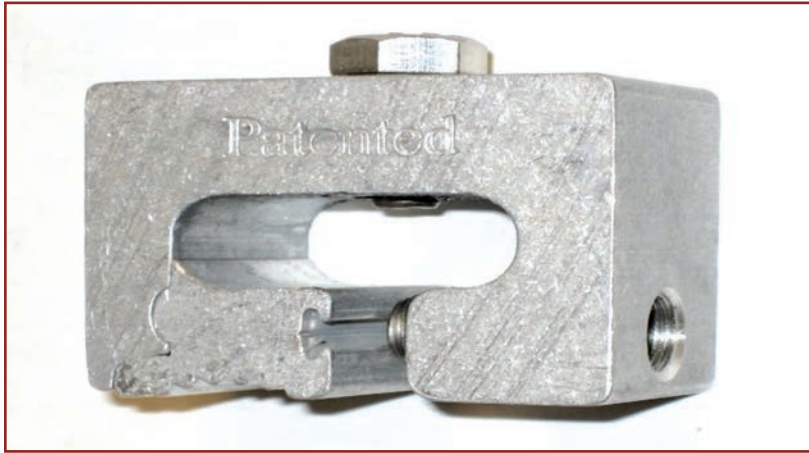
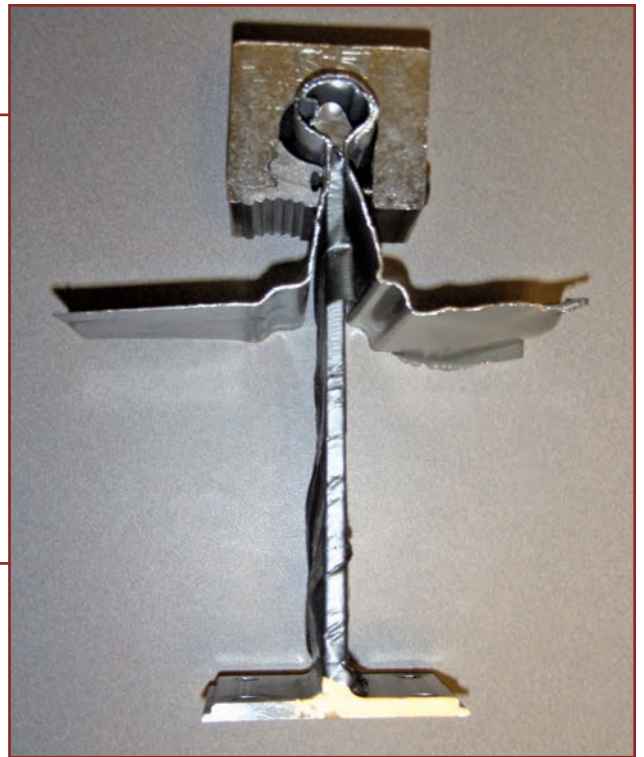
*Figure 6. Examples external seam clamps (ESCs): a two-piece ESC that fits a tee-shaped standing seam roof (SSR) (below); a two-piece ESC that fits a bulb-shaped SSR (at right).*

Given the large variety of ESCs available, there is one to fit almost every SSR (Fig. 6). This includes Australian SSR that are snap-fit type.

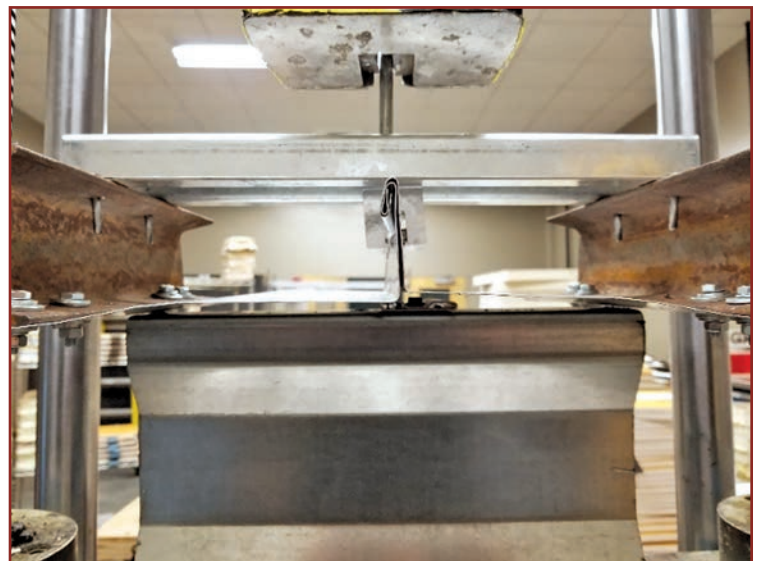
tion of the resultant strength. To be realistic, a small amount of the SSR material plus clips and screws must be provided to mock-up what is installed. A short piece of purlin of a thickness and yield strength equal to that installed can be clamped to the base of the tensile tester, with the ESC directly on the seam and over the internal two-piece clip (or for one-piece clips, use two ESCs, as explained previously). The load should be applied from the top jaws of the equipment to the flat parts of the SSR panel edges (Fig. 7).

*Figure 7. Small-scale test to estimate enhanced strength of a standing seam roof with external seam clamps.*

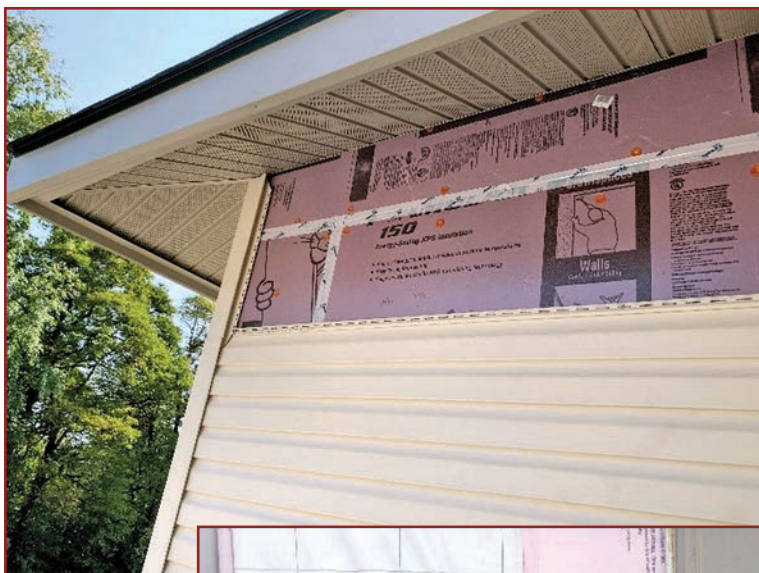
*Figure 3. Vinyl lap siding veneer over continuous insulation.*

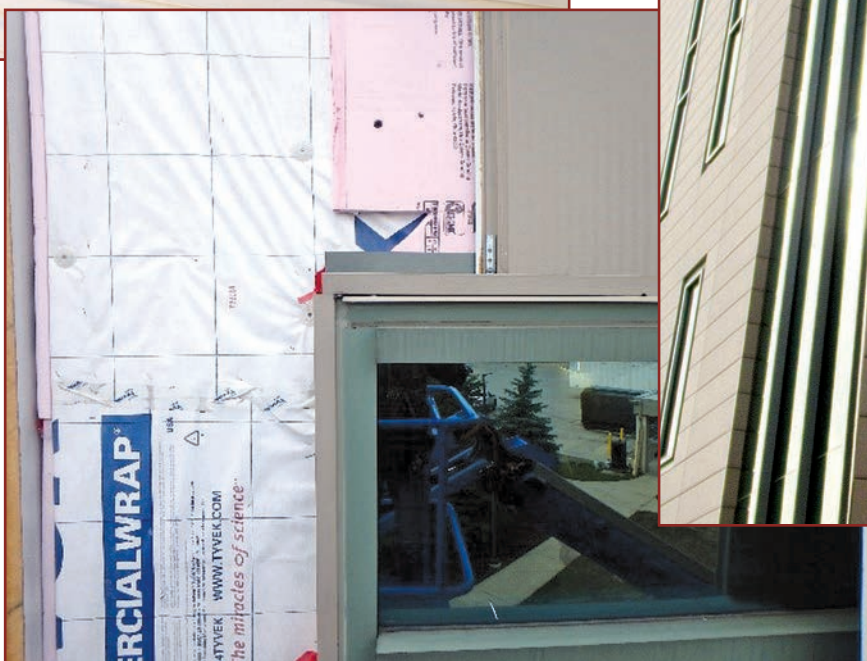
*Figure 4. Panelized composite metal veneer over continuous insulation.*

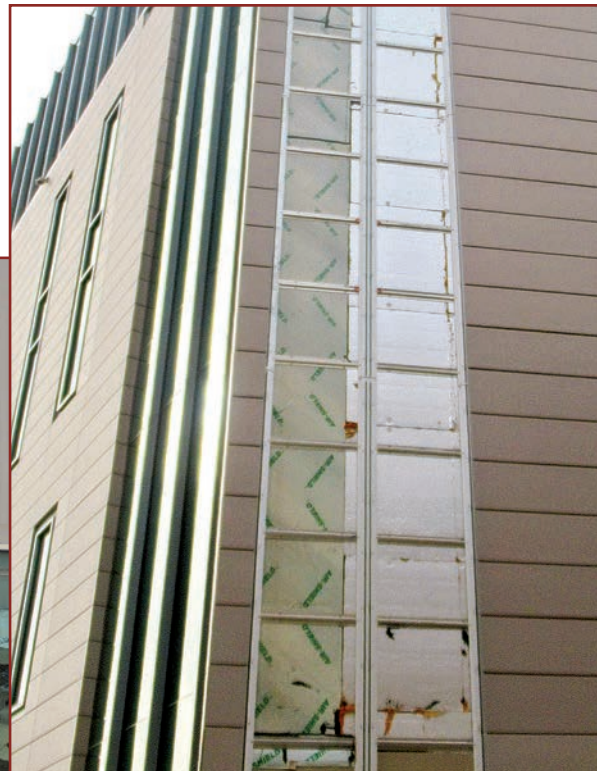
*Figure 5. Terra-cotta rain screen veneer over continuous insulation.*

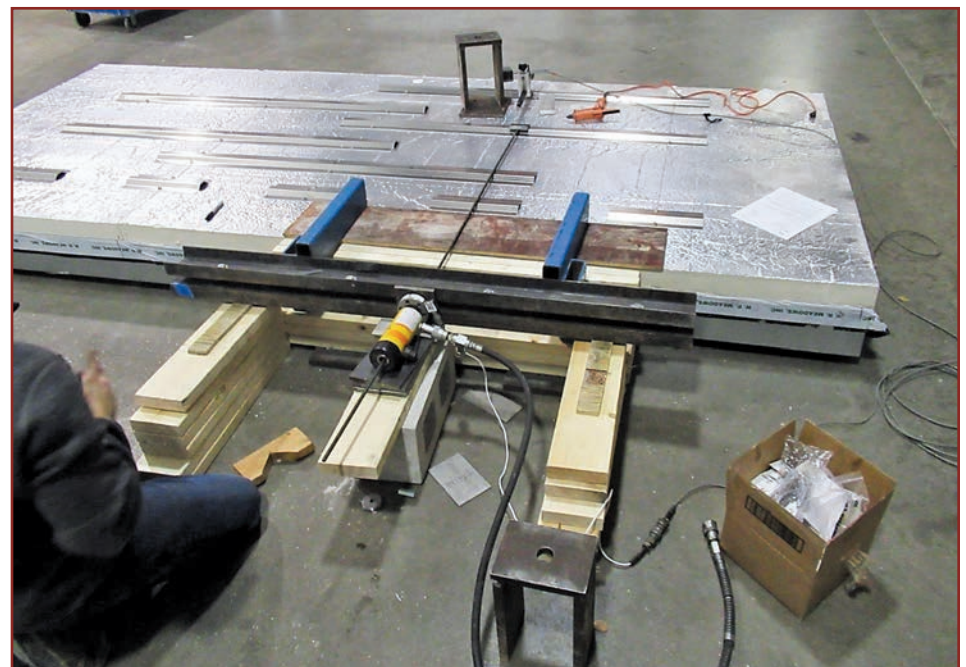
The testing procedure loaded the specimens monotonically to service loads and beyond while load and displacement data were collected. In these project-specific tests, deflections at service loads were consistently below the project-specified service load deflection limit of  $\frac{1}{16}$  in. (1.6 mm). To demonstrate adequate strength, test loads were increased

**Figure 14.** Testing apparatus developed by the authors to quantify key performance features of surface-mounted connections on a structure with a relatively heavy veneer.

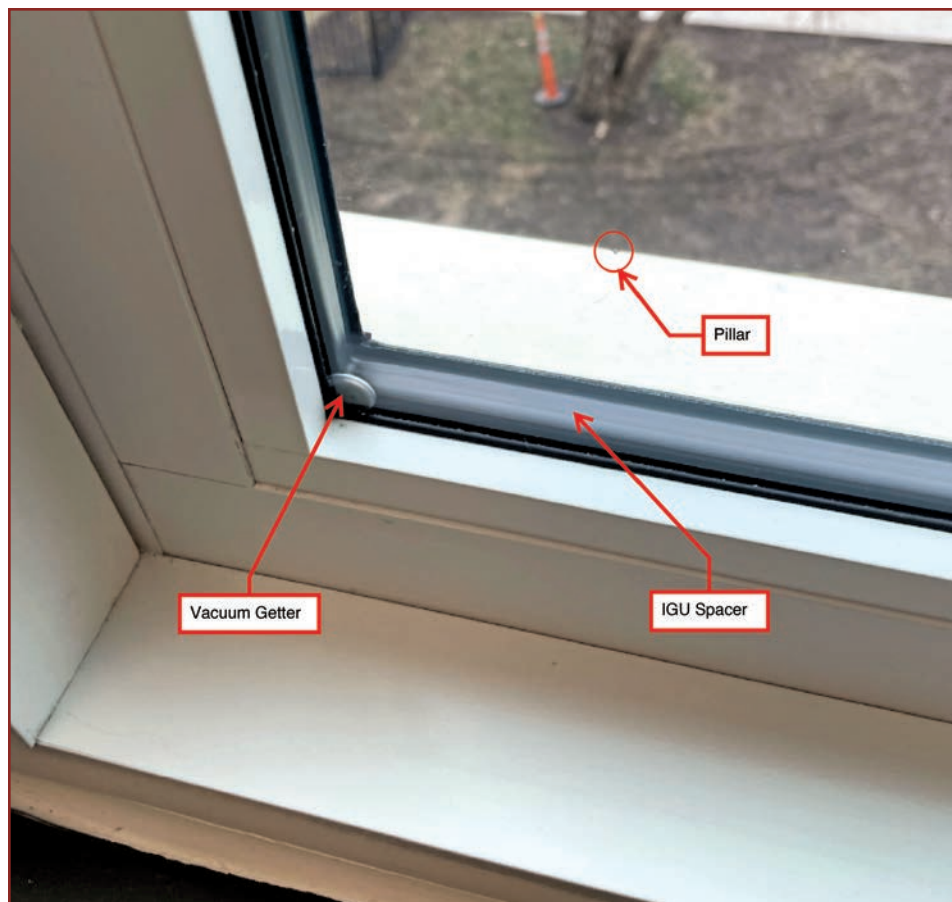
**Figure 6.** A corner of a hybrid-vacuum-insulated glass unit. Note: IGU = insulating glass unit.

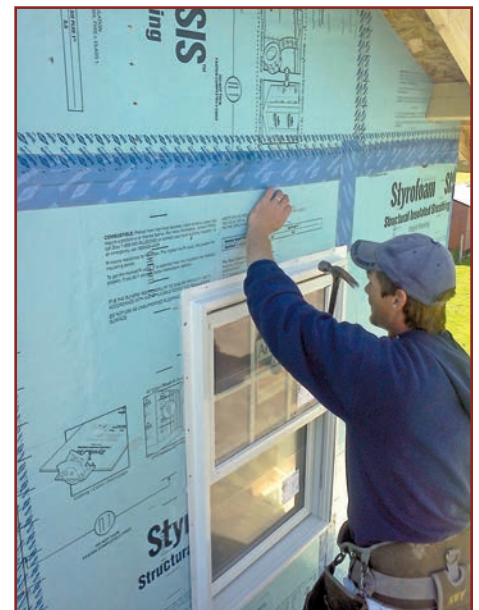
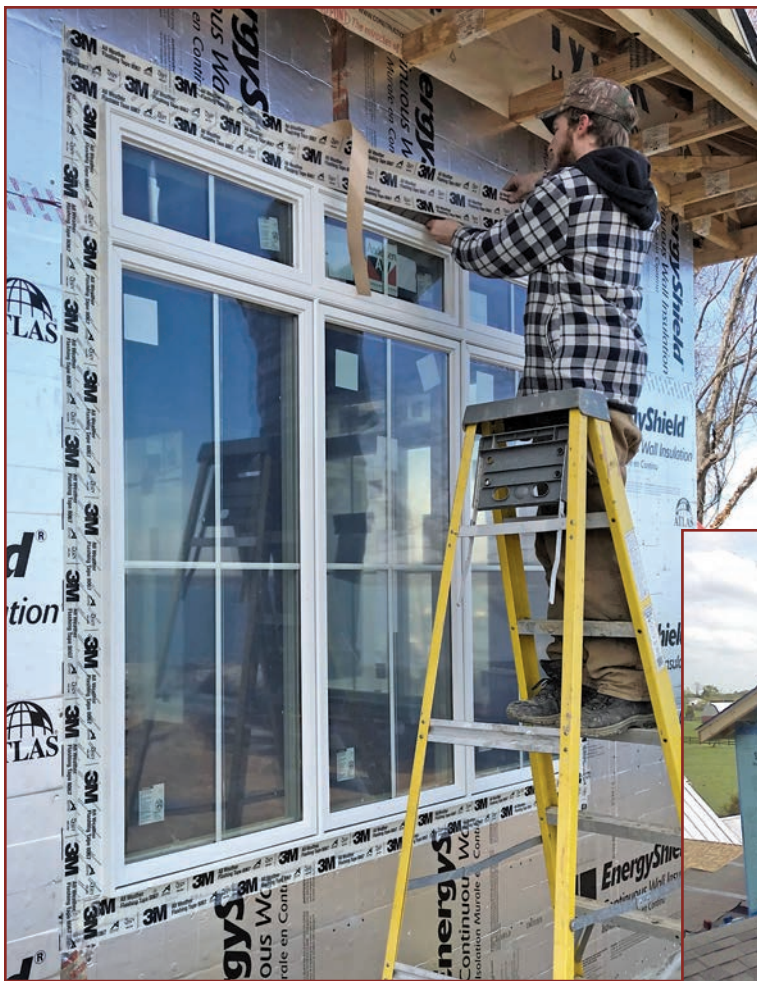
*Figure 4. Adhered flashing and joint tapes used for foam plastic insulating sheathing water-resistive barrier systems and window flashing.*

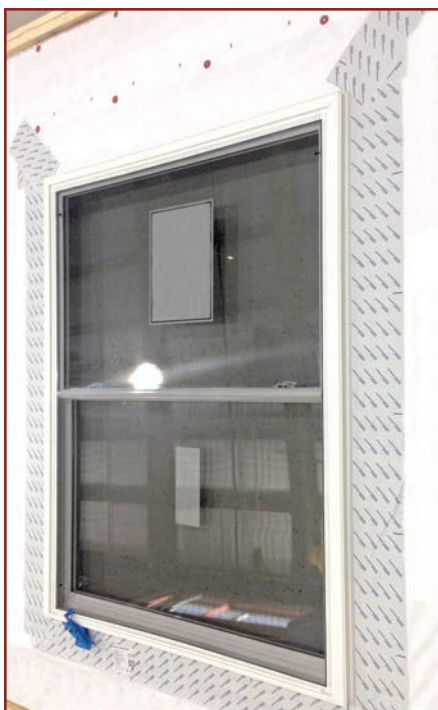
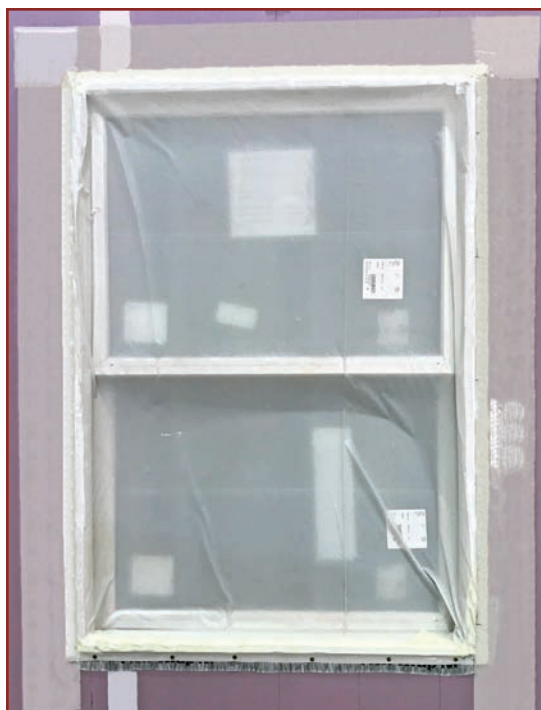
**Figure 6. Adhered flashing as installed at window perimeters in test specimens with a building wrap water-resistive barrier (left) and with foam plastic insulating sheathing water-resistive barrier system (right).**

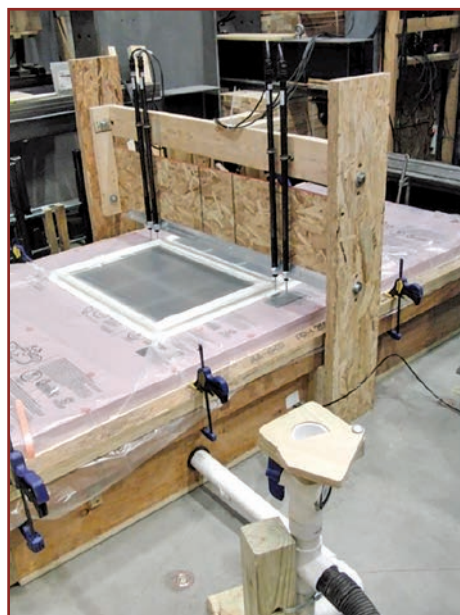
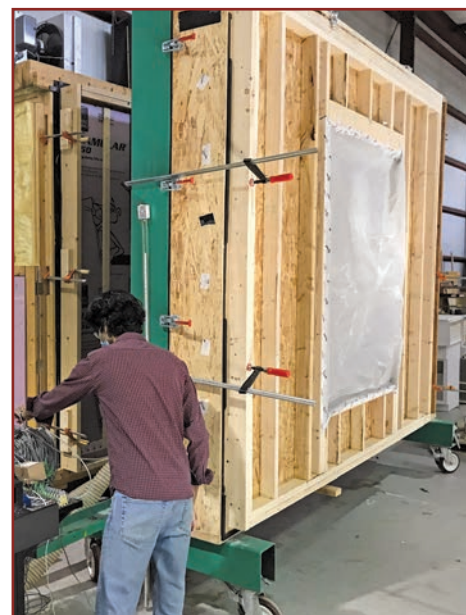
**Figure 7. ASTM E330<sup>23</sup> test apparatuses used to evaluate uniform pressure resistance. Figure: Qualtim/Center for Building Innovation (left); Home Innovation Research Labs (right).**

Figure 7 shows the two ASTM E330<sup>23</sup> test apparatuses used in this investigation. In general, both positive- and negative-pressure

tests were conducted on the same specimen with positive-pressure testing conducted first. With two exceptions, all tests were conducted in a sequence of targeted pressure levels:  $0.5 \times$  DP (preload),  $1.0 \times$  DP (design pressure),  $0.75 \times$  DP, and  $1.5 \times$  DP (STP). For each targeted pressure level, the load was held for 10 seconds, released for a pause, and then the next pressure level was applied. For two test specimens, the test pressure was ramped to failure (above the window's STP) to determine the ultimate capacity and failure mode rather than just a "pass/fail" proof load test.

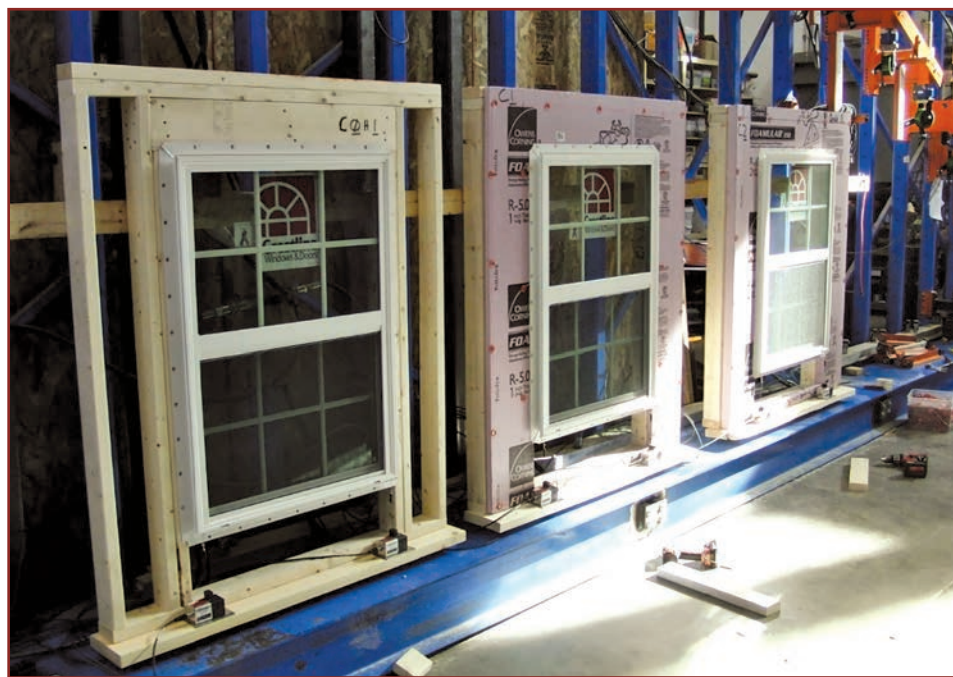
**Figure 8. Sustained dead load tests for creep and stability. Figure: Qualtim Inc. 2013. Creep of Fasteners Installed into Windows over Foam Sheathing Panels and OSB. Madison, WI: Qualtim Inc.**

In addition to structural wind pressure testing and water resistance testing, investigators conducted tests to evaluate the movement of the fenestration unit when subject to a period of sustained dead load (window self-weight). **Figure 8** shows an example test setup. Maximum downward (negative) movements of 0.000 to -0.032 in. were recorded for monitoring durations of 20 days (two specimens) and 6 months (all other specimens) for installations including up to 2 in. of FPIS and window weights ranging from 27 to 384 lb. There were no obvious trends relative to weight, size, or type of window, or foam thickness and compressive resistance. In some cases, periods of positive (upward movement) occurred, which indicates that some portion of the measured positive and negative movements may be

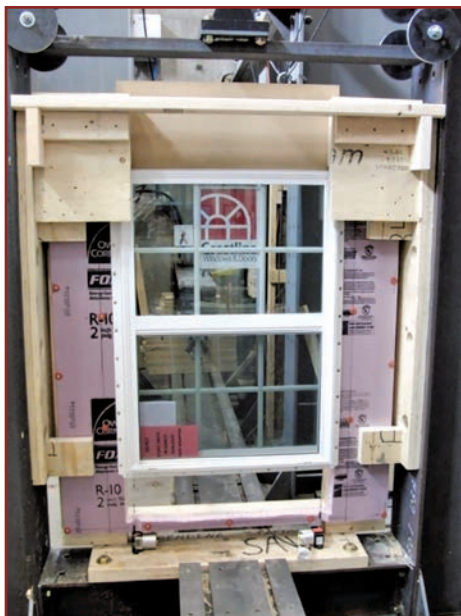
**Figure 9.** Window installation shear load test setup.
