# Proceedings

IIBEC 2022 - Building for the Future

# Proceedings of the IIBEC International Convention and Trade Show

# Nondestructive Testing Methods in Structural and Building Enclosure Assessment

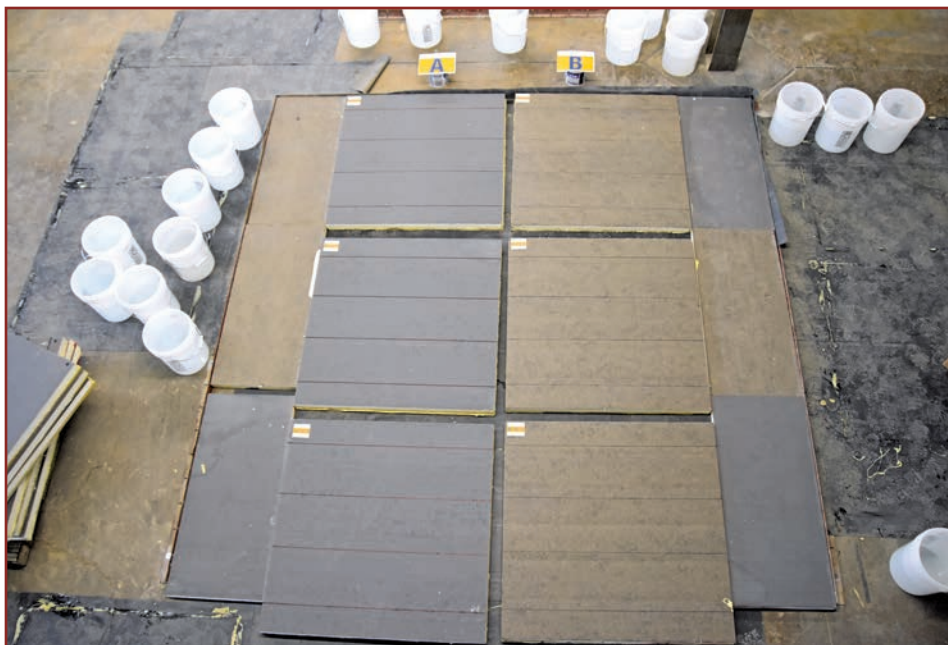
*Figure 1. Lines were drawn on the insulation boards (with spacings centered on boards) to guide the application of the low-rise foam adhesive ribbons. The lines were centered so that application of the adhesive would be symmetrical. The photo shows the line layout for a 12 in. ribbon spacing.*

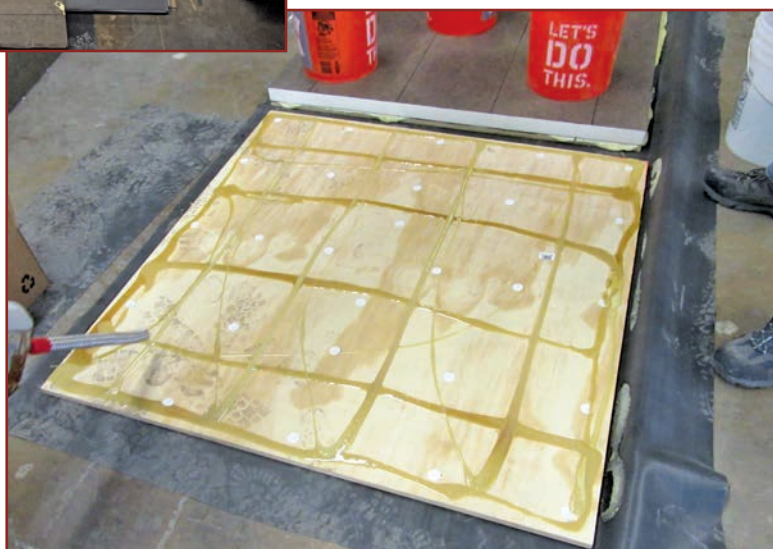
*Figure 3. Typical low-rise foam adhesive bead width being applied to two separate insulation boards with 18 in. ribbon spacing lines.*

After setup and curing, the two-part polyurethane adhesive was applied in ribbons onto half of the specimen along the highlighted markings at designated ribbon spacing. The foam adhesive ribbons were applied at an initial application width of approximately  $\frac{3}{4}$  in. (Fig. 3). The foam ribbons were installed in straight, parallel lines from one end of the insulation board to the other, in lieu of a ser-

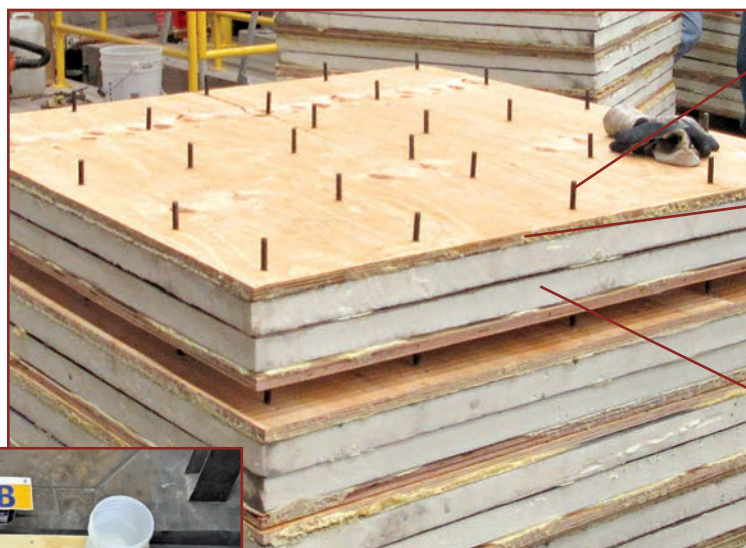
*Figure 4. Typical weights used as ballast until the foam adhesive set up, typically for 10 to 15 minutes per specimen.*

The two-part polyurethane foam adhesive was initially installed onto the plywood board surfaces in ribbons approximately 6 to 9 in. on center in each direction (Fig. 2). Immediately after placement of the adhesive, insulation boards were installed on the prepared plywood boards. Five weighted buckets, approximately 26 lb each, were placed on the insulation boards, one at each corner and one in the center. The buckets remained in place for approximately 10 to 15 minutes while the adhesive cured. The adhered plywood and insulation halves for each of the specimens were allowed to set up and cure between 12 to 24 hours before final assembly.

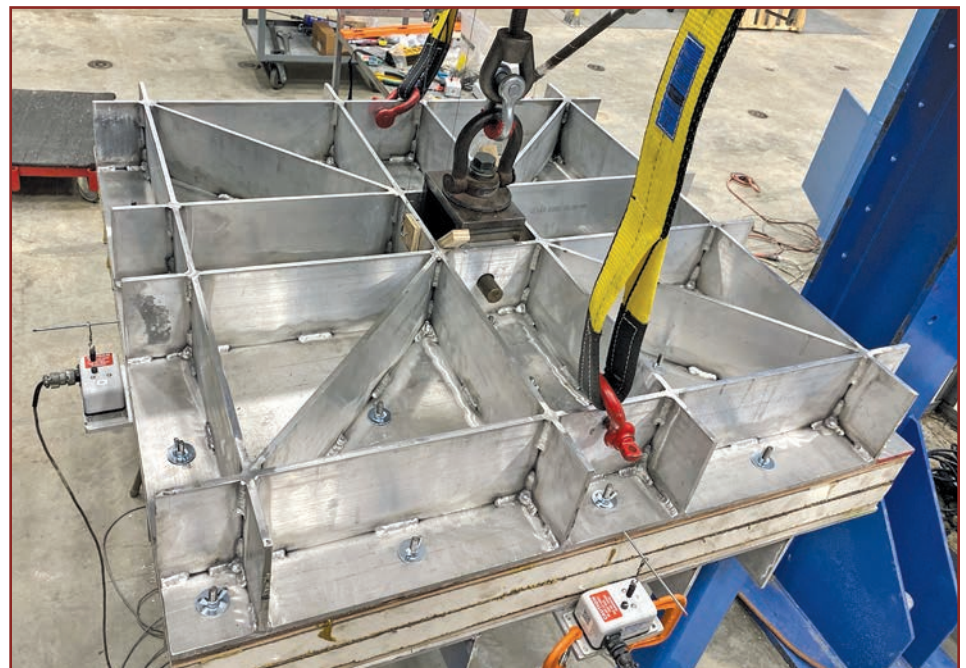
*Figure 10. A stiffened aluminum test frame and secured insulation board test specimen.*

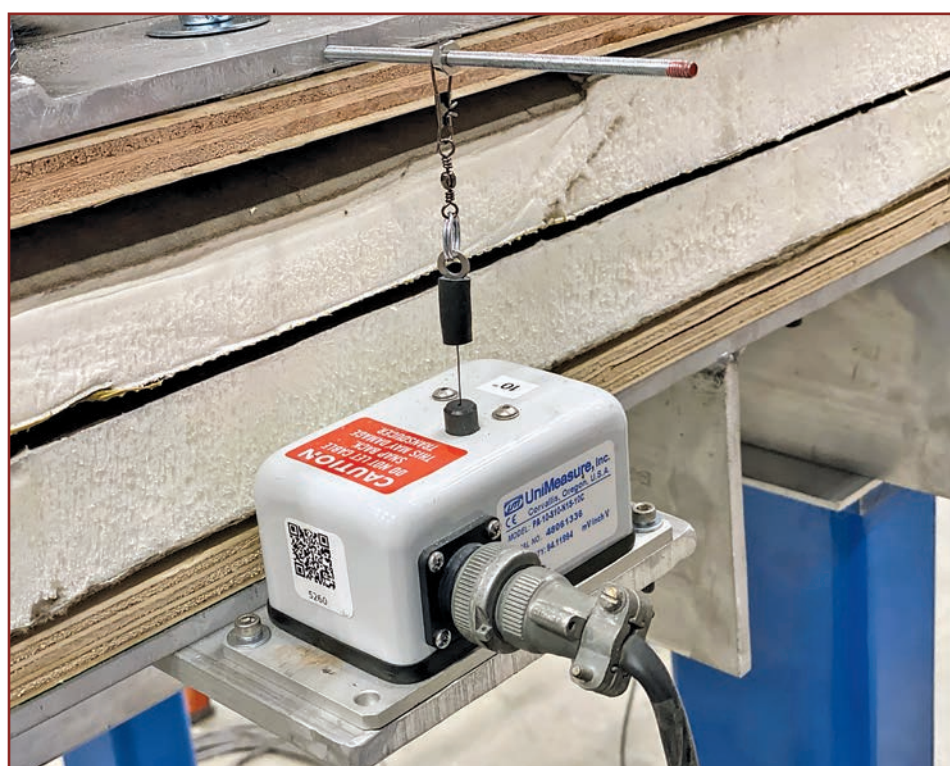
**Figure 13.** Displacement transducer positioned at the edge of a test specimen to measure separation and elongation of insulation during testing.

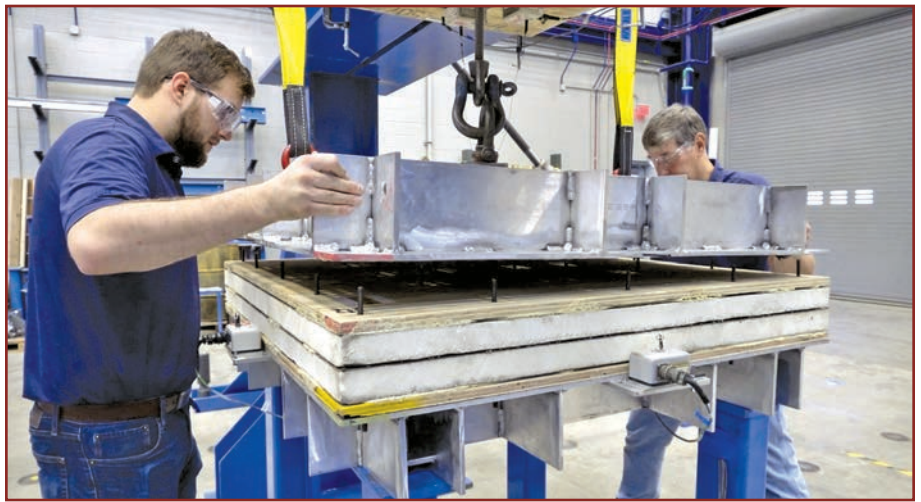
Figure 14. Positioning the upper aluminum load frame onto a test specimen.

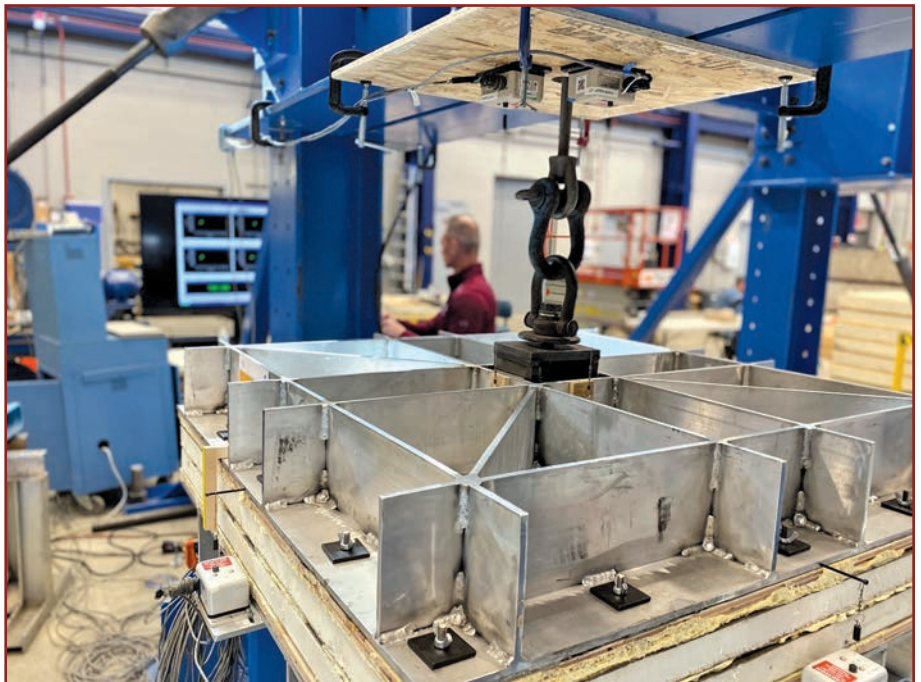
Figure 16. Application of axial load to a test specimen.

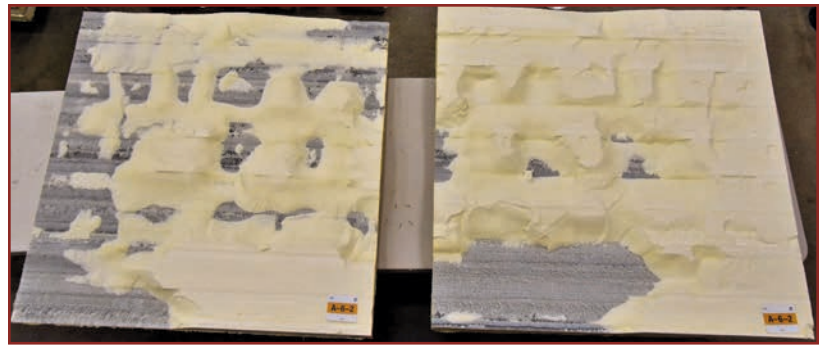
*Figure 21. Specimen A-6-2 shown in separated fashion, similar to an opened book. The plane of failure was primarily within the foam core of the top facer of the insulation board (left image), with some delamination at the bottom glass fiber facer of the board (right image).*

ic felt or the coated glass fiber facers) and some cohesive failure of the foam core. Cohesive failure of the foam core was most prevalent in the specimens with 6 and 12 in. ribbon spacings and occurred to a lesser extent in the specimens with 18 in. ribbon spacing. For the specimens with 18 in. ribbon spacing, the primary failure plane was delamination and separations from the insulation facers. After testing, each specimen was placed on a table for examination and documentation. Representative examples are shown in **Fig. 21, 22, and 23**.

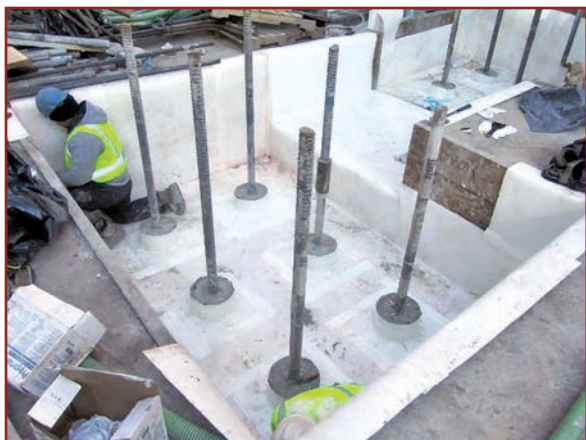
**Figure 3.**  
*Rock anchor  
penetrations  
through  
foundation  
waterproofing.*

waterproofing approaches than foundations using secondary structural elements such as “mat slabs” (thickened mat or raft foundation). Stabilization systems can include post-tensioned cables or rods grouted into the rock and/or soil. After the permanent foundation elements have been constructed, the anchors are tensioned and locked off with an anchor plate and nut (Fig. 3).

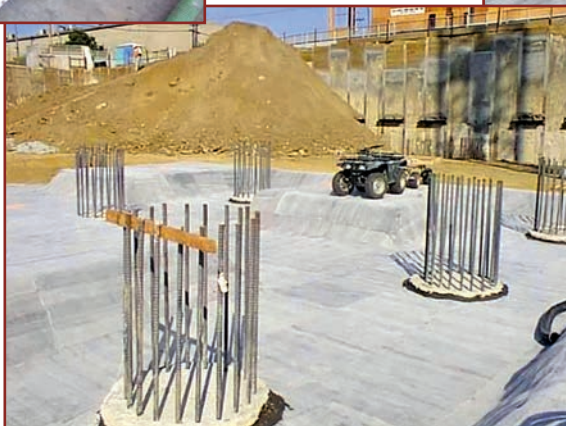
**Figure 5.** *Pile caps.*

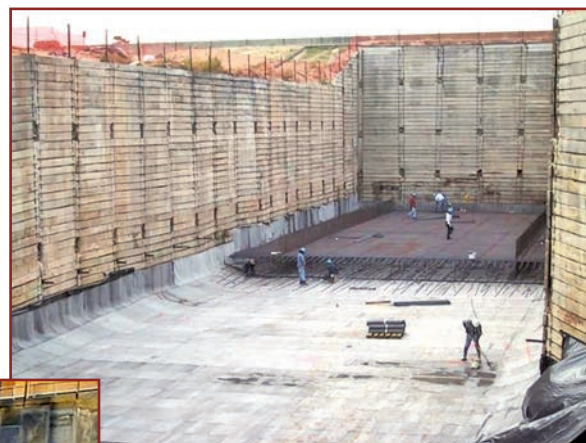
**Figure 4.** *Mat slab under construction.*

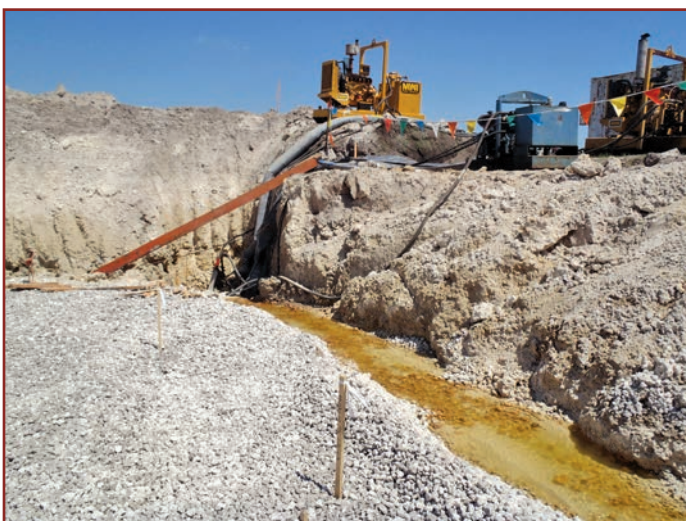
Figure 8. A dewatering pump station at a perimeter trench at the corner of the building pad.

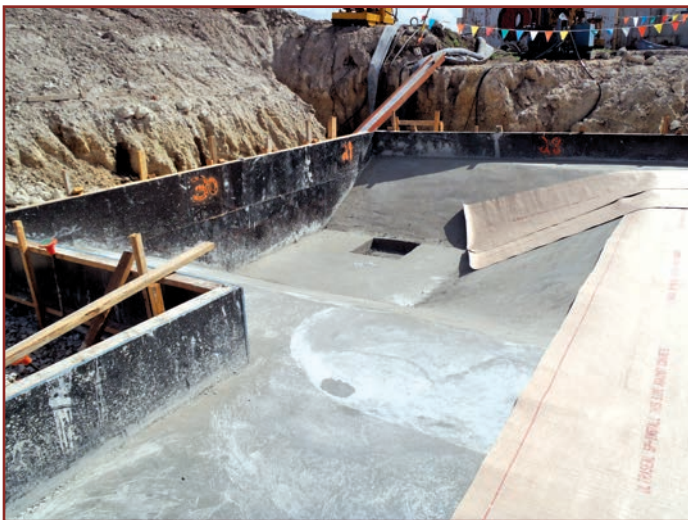
**Figure 10.** A horizontal bentonite waterproofing sheet being placed at the elevator pit.

joints and 90-degree transitional corners at the membrane (Fig. 10). The reinforced horizontal concrete slab at the pit was designed to be thick enough to resist the force of the hydrostatic pressure.

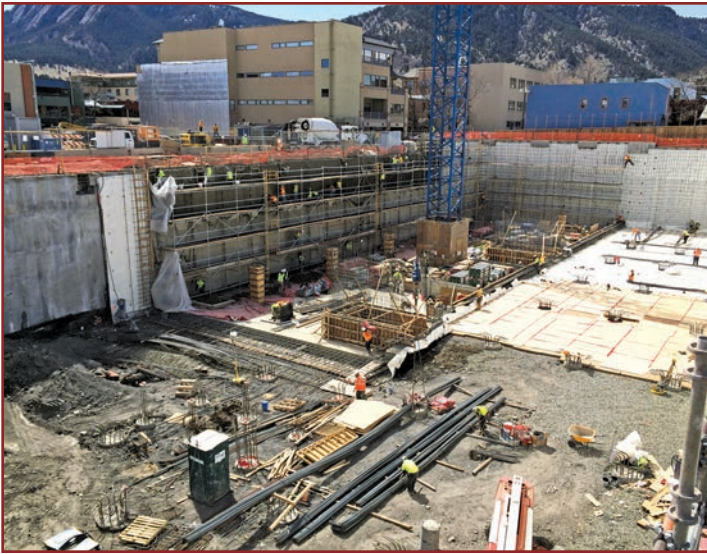
*Figure 13. View of the preapplied sheet waterproofing being installed over the support of an excavation wall at a zero-lot line condition.*

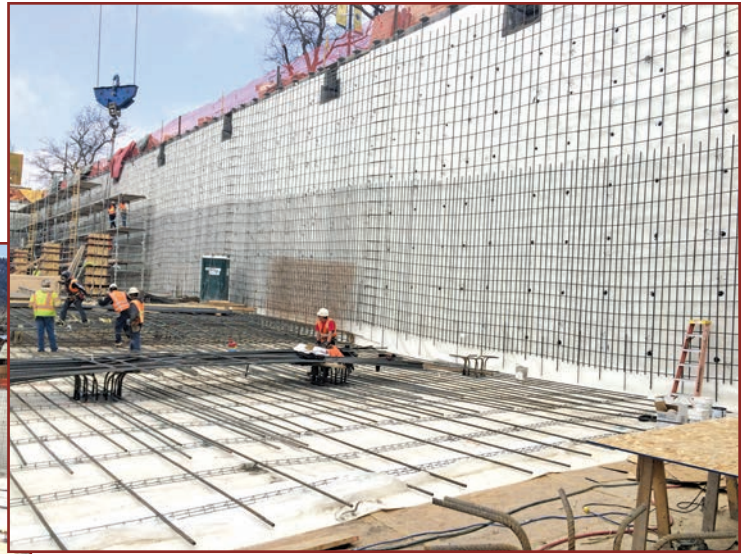
*Figure 14. Reinforcing steel being installed over the top of pre-applied sheet waterproofing.*

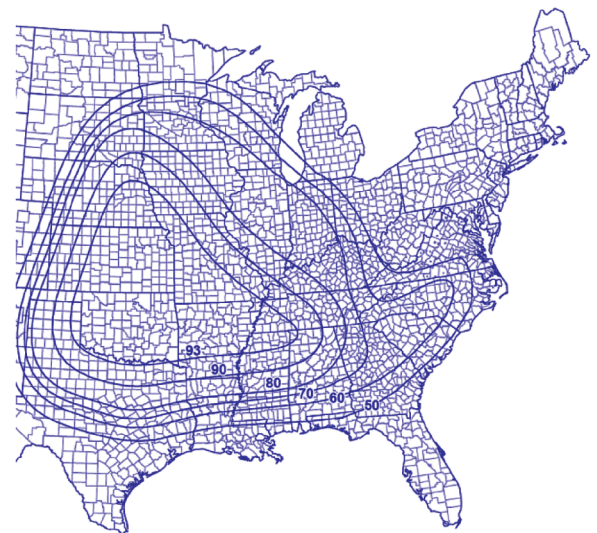
Figure 32.5-1E (Continued). Tornado speeds for Risk Category III buildings and other structures, for effective plan area of 100,000  $ft^2$  (9,290  $m^2$ ).

Figure 5. Tornado design wind speed map in ASCE 7-22. Figure reprinted with permission from ASCE.

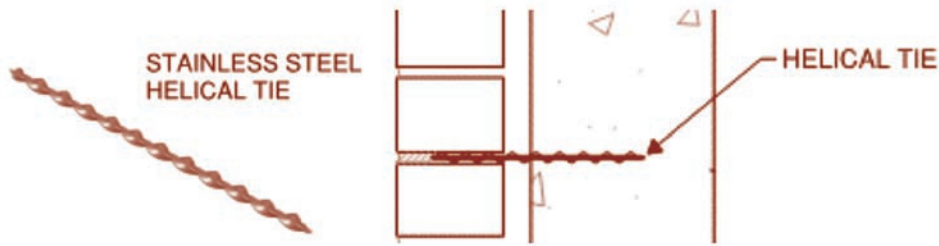
**Figure 2.** General detail for helical ties for a brick veneer system.

2 × 2 ft section of the veneer had fallen. The repairs consisted of the installation of helical ties throughout the brick cavity walls in an effort to provide additional anchorage of the brick veneer and address the observed outward displacement of the brick veneer. Helical ties can be installed through existing mortar joints to reanchor brick veneers (Fig. 2).

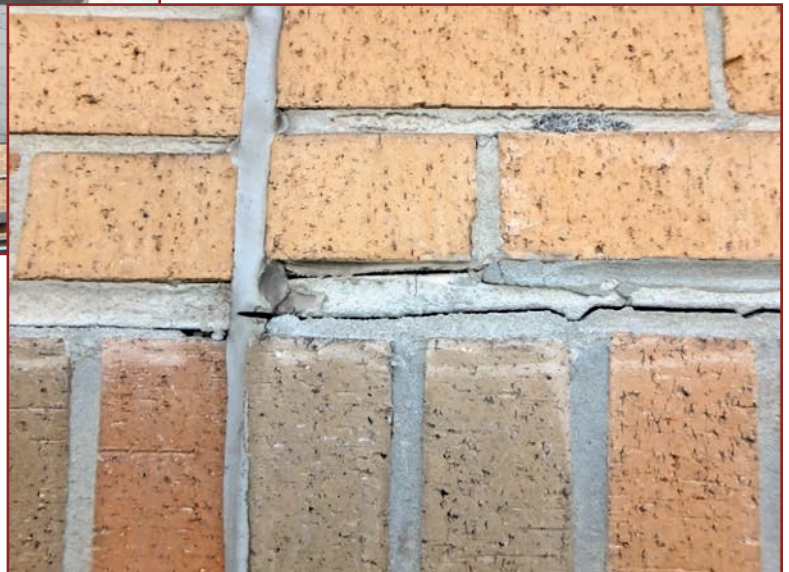
**Figure 4.** Typical brick mortar joint cracking.

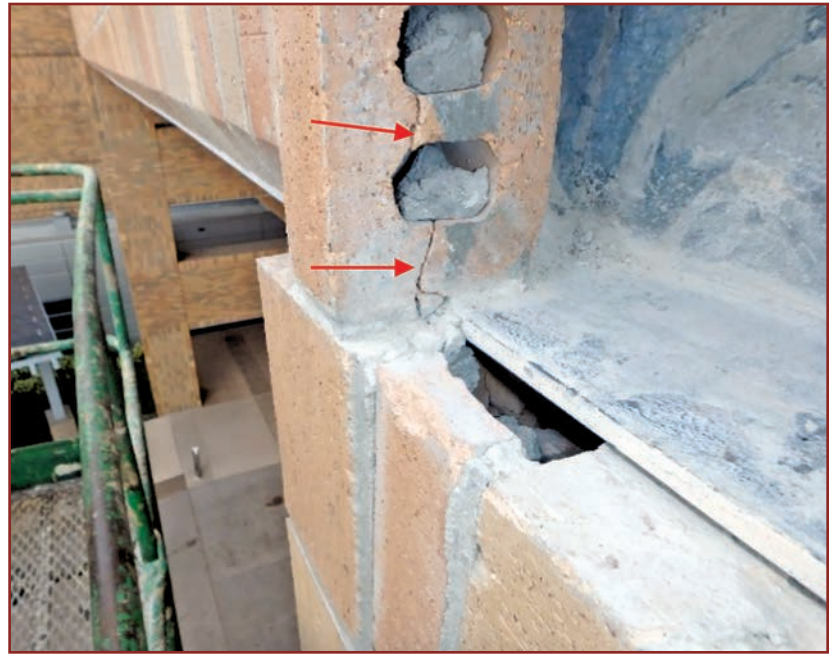
Figure 6. Vertical fractures and brick bearing less than two-thirds of the brick depth.

Observations at exploratory openings	Contribution to brick veneer distress
Vertical fractures of bricks ( <a href="#">Fig. 6</a> )	Full-depth vertical fractures (likely caused by compressive forces acting on the brick in the vertical direction) have greater potential for spalling.
No vertical expansion joints at building corners and setbacks	Without vertical expansion joints at regular intervals and at building corners, brick movement due to thermal expansion is restrained, and brick cracking and/or spalling may occur ( <a href="#">Fig. 7</a> ).
No horizontal expansion joint at shelf angles	Without horizontal expansion joints at regular intervals, brick “stacking” can occur, where the dead load from the bricks’ self-weight is transferred from floor to floor. This can create high compressive stresses in the brick at lower elevations of a building. Additionally, differential movement between the brick and steel shelf angle due to thermal expansion and contraction cannot be accommodated, and brick cracking may occur ( <a href="#">Fig. 8</a> ).

The team made 33 exploratory openings throughout the brick facade during the assessment to gain a better understanding of the existing as-built conditions. Table 1 summarizes some of the as-built deficiencies observed at the exploratory openings, and how each was likely contributing to the observed distress. Figures 6 through 9 illustrate selected concerns.

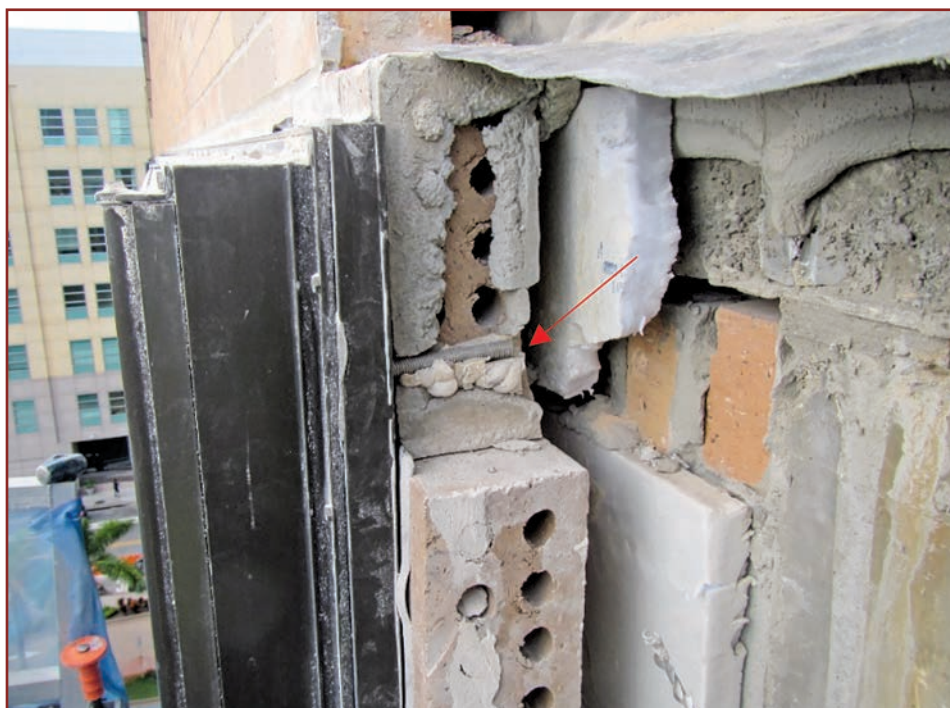
**Figure 14. Hurricane shutter anchorage was not attached to structure.**

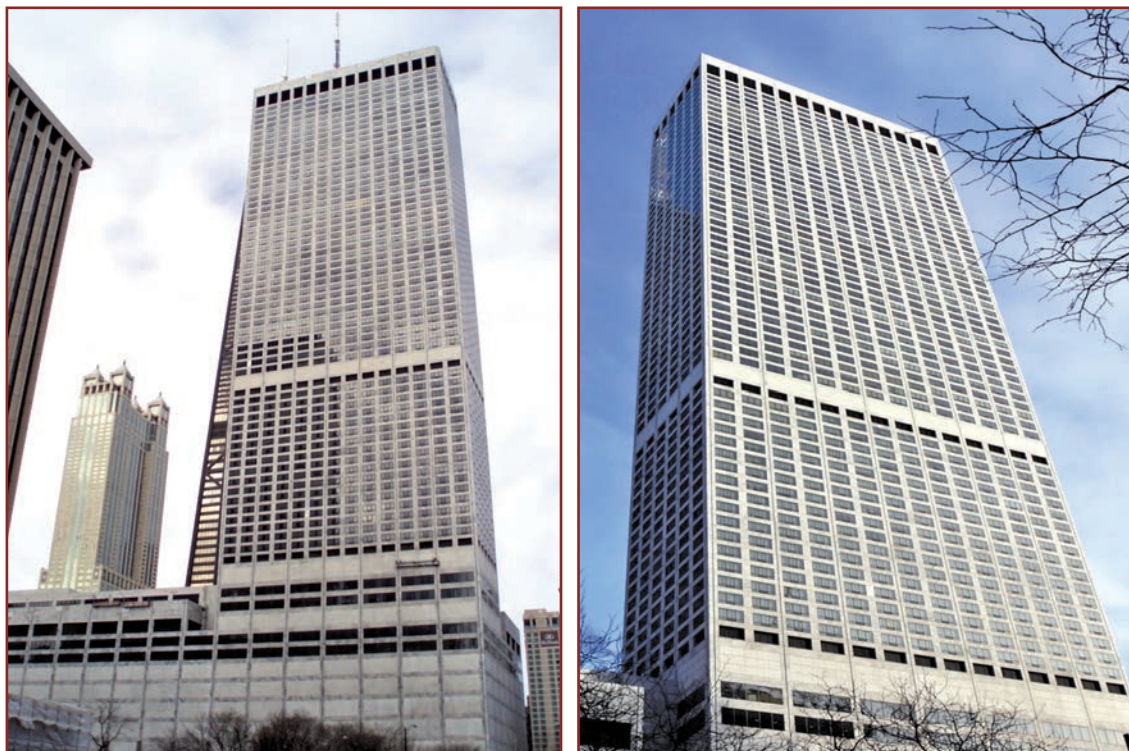
Figure 2. Water Tower Place's north elevation (left) and south elevation (right).

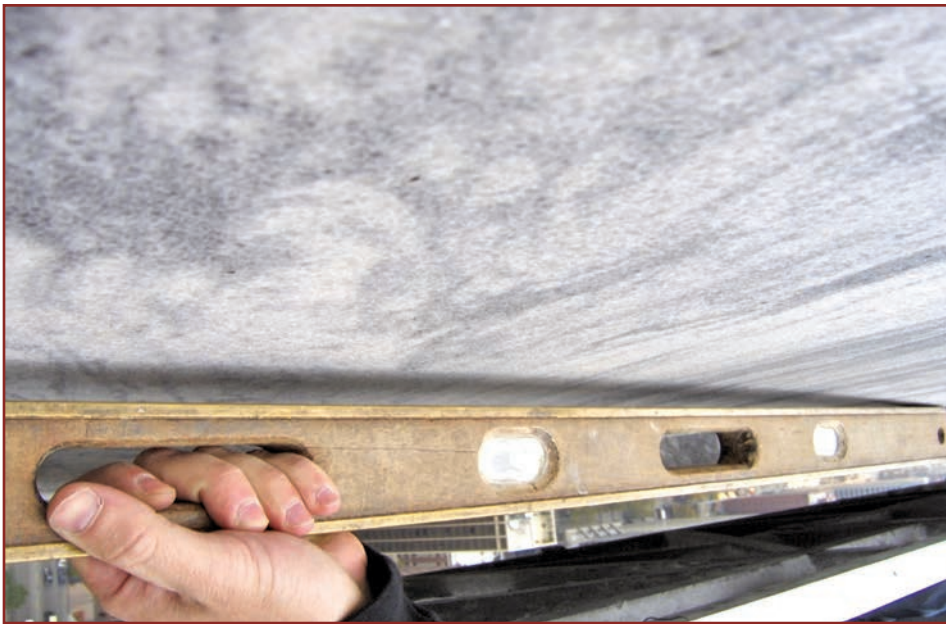
**Figure 3. On-site marble bowing in relation to a straight 4 ft level.**

Among the key concerns about the custom restoration anchors was whether they would restrain the panels from bowing and in so doing create stress cracks within the panels. TT studied this problem by inducing the observed bowing (up to 1 in.) into the analytical models to understand the magnitude of stress that such deformation would create. They found that the panels would rupture under such deformation. Because this had not occurred and signs of it had not been observed in the field, TT concluded that the panels undergo stress relief, such that the bowing occurs but does not create residual stresses within the marble. In other words, the panels bow into a certain shape, but little if any residual stress develops within the marble. Therefore, new restraints such as the custom restoration anchors would create new deformed shape patterns for the marble, but they would not induce cracking.

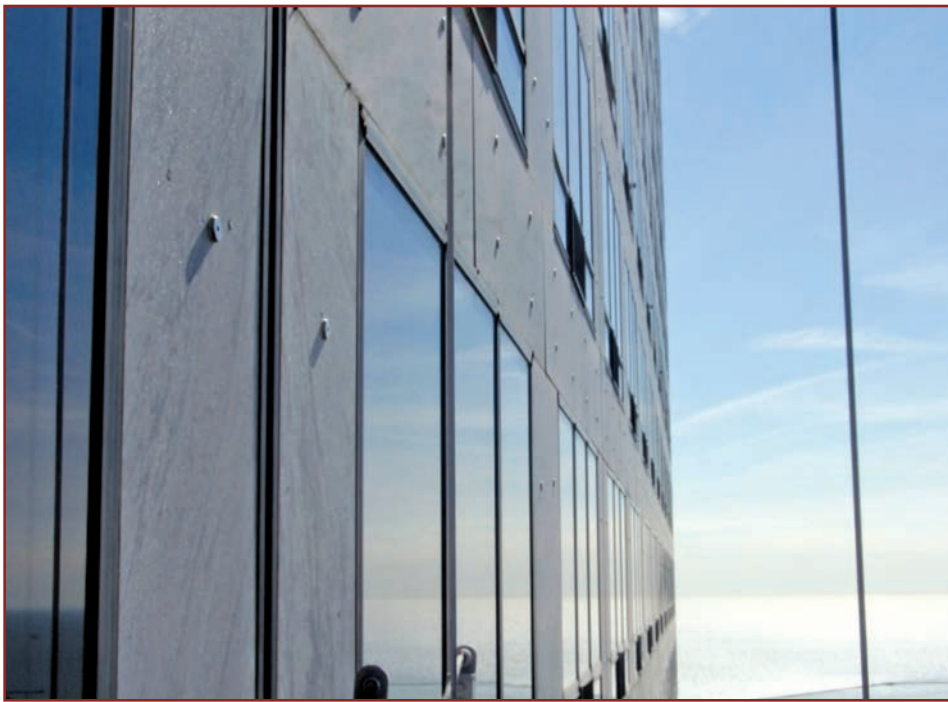
**Figure 5. Overview of custom stone anchors installed on the marble facade.**

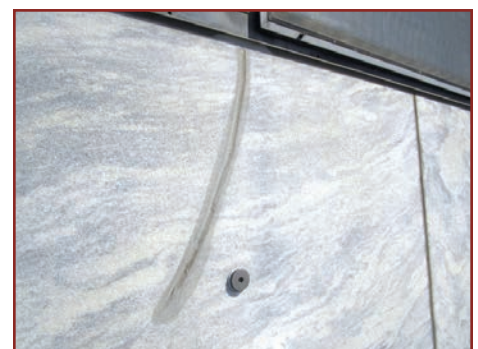
Figure 8. Typical stress crack that has been routed and sealed.

when stone is subjected to wind pressure or suction. Inspectors have typically indicated that the stress cracks seem to be through-thickness cracks. The stress cracks observed have been pinned such that at least one anchor is present on either side of the crack. Anchors used for this purpose are either the CTP custom anchors or helical anchors, depending on the area of the unsupported stone.

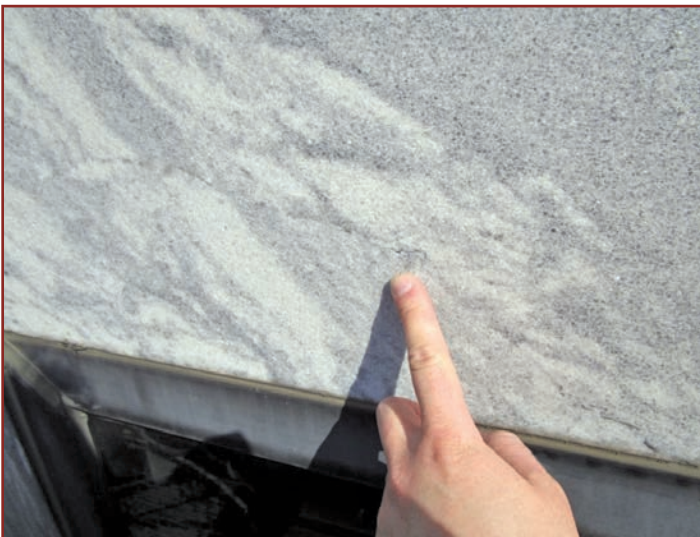
Figure 9. Typical fissure crack.

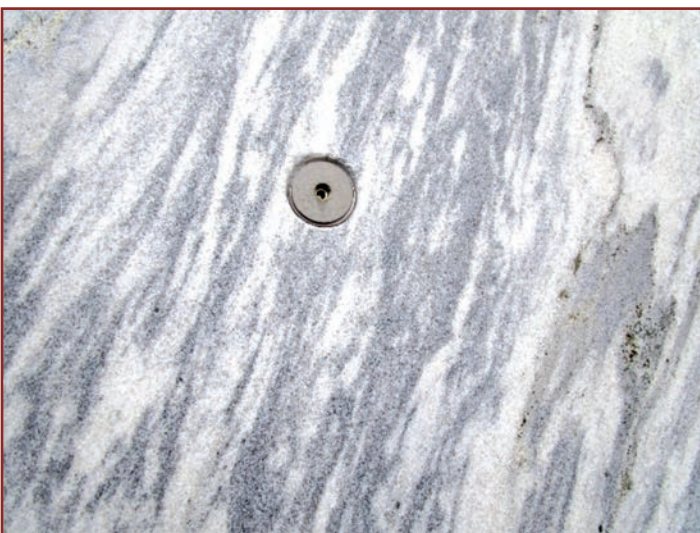
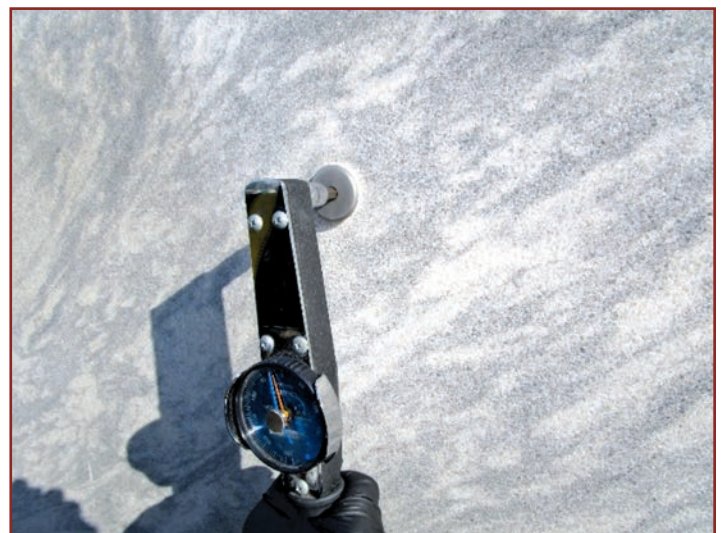
Figure 10. Installed custom stone anchor into the marble cladding (left) and torque testing (right).

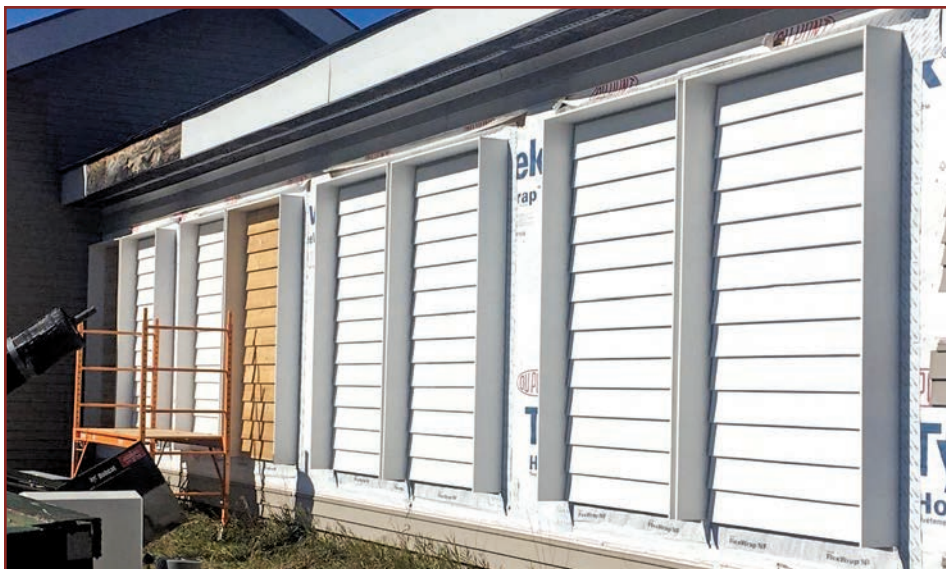
Figure 3. Exterior view of baseline walls depicting cedar siding before wall retrofits.

To assess the impact of wall retrofits, a baseline wall assembly was designed and used as the starting point for each wall assembly and 16 identical test walls were constructed for each phase. The baseline test walls were constructed of 2 × 4 in. (51 × 102 mm) spruce, pine, or fir wood studs with 1 × 6 in. (25 × 152 mm) pine board exterior sheathing. The pine sheathing was loosely fit to reflect older construction. The sheathing was covered with a heavy no. 30 building paper lapped and stapled to the sheathing followed by 8 in. (203 mm) cedar lap siding finished with an oil-based primer, vapor-retarder primer, and latex topcoat. This exterior finish was selected to represent an older house with several coats of oil-based paints. Once the test panel was installed in the test opening and the instrumentation array was installed, an interior finish of 5/8-in.-thick (16-mm-thick) gypsum board with a vapor-retarder primer was added. The interior finish was selected to represent an older house with heavy drywall or plaster and several coats of paint. The south-facing baseline walls from Phase 2 are shown in Fig. 3. Team members familiar with construction practices in the local climates indicated that vapor retarders were not historically included in construction practices for the time period that was being considered for initial constructions. Since the majority of retrofits were to be performed on the exterior side of the wall assembly, access to the interior side of the cavity was unavailable and therefore vapor retarders were not included in most of the retrofits.

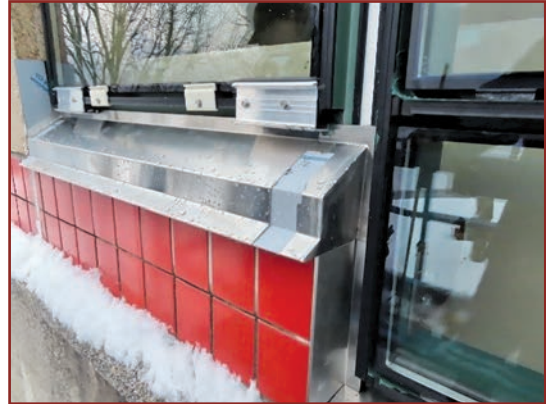
When constructing the window-to-cladding interface, on-site mock-ups can be an invaluable tool for assessing constructability of flashing systems and determining whether supplemental flashing is needed.

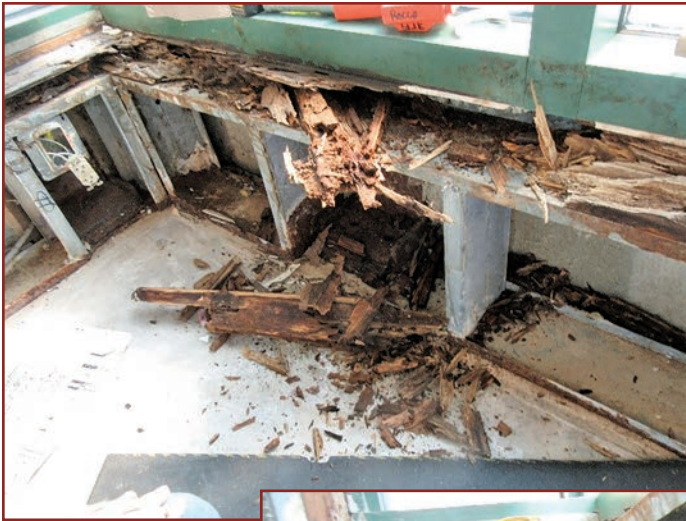
*Figure 1. Decaying wood below a window frame.*

water leakage is that it can enter the wall system below the window. This water might be absorbed by interior drywall and wood sheathing and framing, or if the wall is framed with metal studs, it can collect in the stud tracks. Long-term water intrusion can result in substantial damage to the exterior wall, including decay of wood framing, deterioration and erosion of fire-rated gypsum drywall or sheathing, organic growth, and corrosion of structural metal wall framing (Fig. 1 and 2).

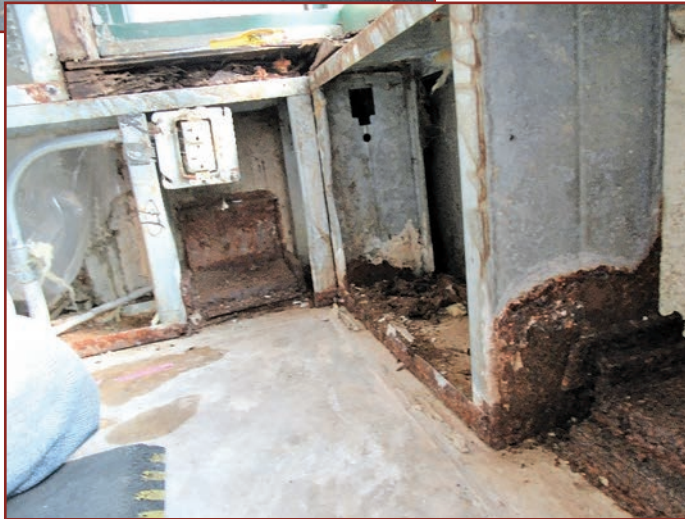
*Figure 2. Corrosion of metal track and studs.*

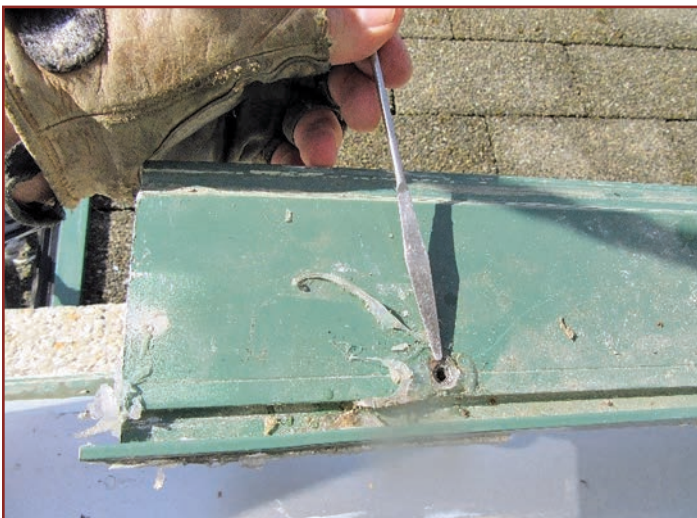
*Figure 3. Fastener penetration through a subsill.*

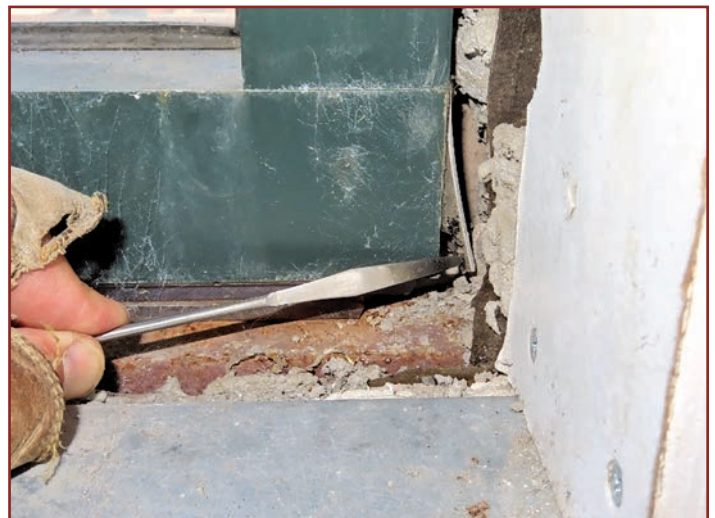
*Figure 4. A loose end dam at the end of a sill.*

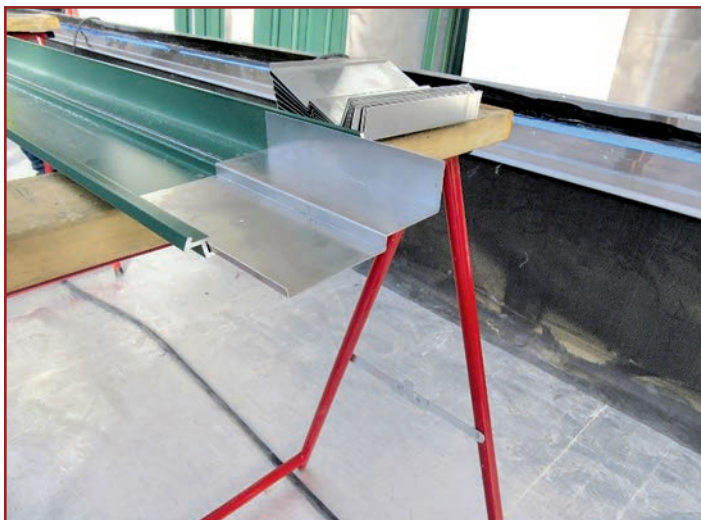
**Figure 5.** A subsill butt joint cover.

A watertight subsill component is important to achieve a weathertight window interface with the air/weather barrier. When installing a window manufacturer's subsill component, sealing the gap between butt joints can be accomplished by fabrication and installation of butt joint covers, set in sealant at each end of the joint, that match the profile

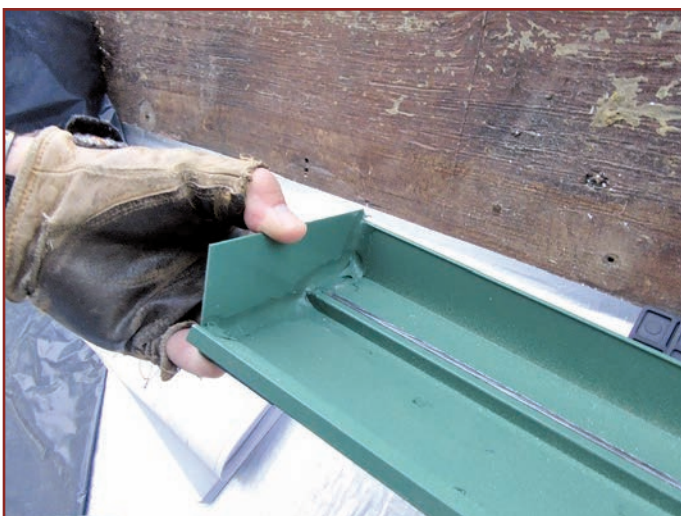
**Figure 7.** A subsill end dam.

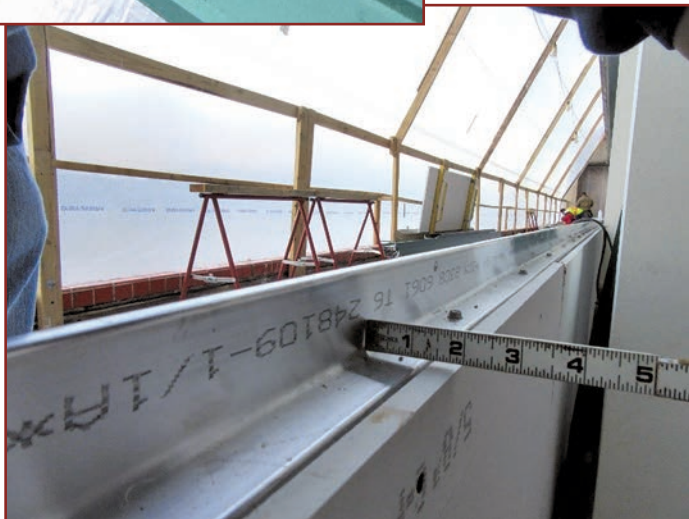
**Figure 8.** An angle bracket.

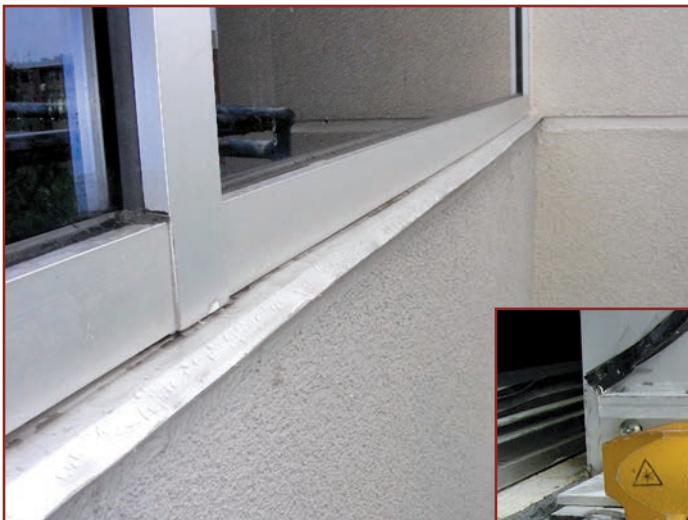
**Figure 9.** The drip edge of a pan exposed at the exterior.

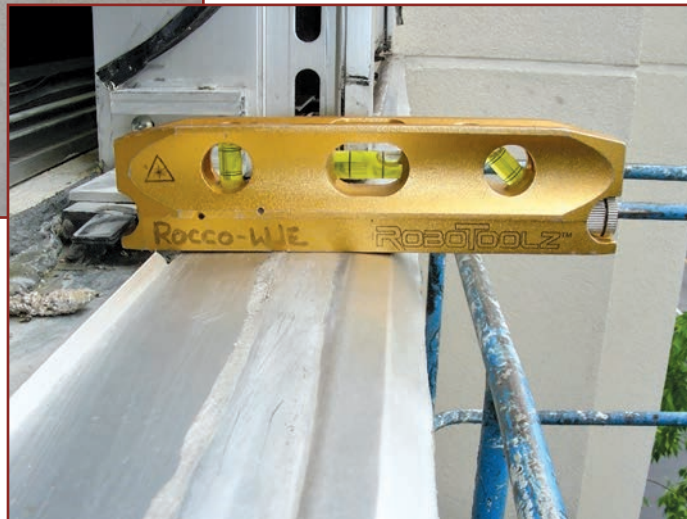
**Figure 10.** A pan is reverse-sloped toward the interior.

water testing reproduced the reported water leakage immediately. After one of the sill components was deglazed and removed, it was evident that the pan terminated underneath the sill component and was reverse-sloped toward the interior (Fig. 10).

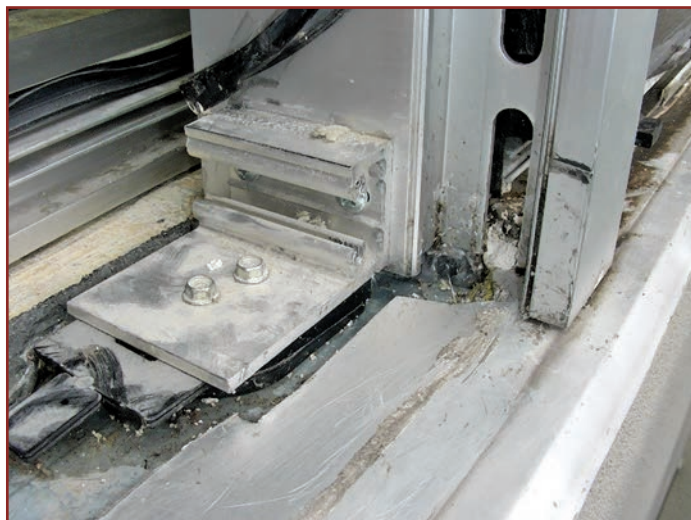
**Figure 11.** The back dam of the pan was cut to fit around the mullion and anchor clip.

During construction, portions of the back dam of the pan had been cut so that the pan could fit around the vertical mullions and anchor clips. The reverse slope of the pan directed water to the areas where the back dam was removed, which in turn provided a direct path for water leakage to the interior (Fig. 11). The sealant joint between the sill and the pan was installed in a haphazard manner, resulting in a discontinuous and ineffective sealant joint, particularly at the vertical mullion locations. In this case, the typical one-component pan was discontinuous due to the obstructions created by the vertical mullion anchor clips.

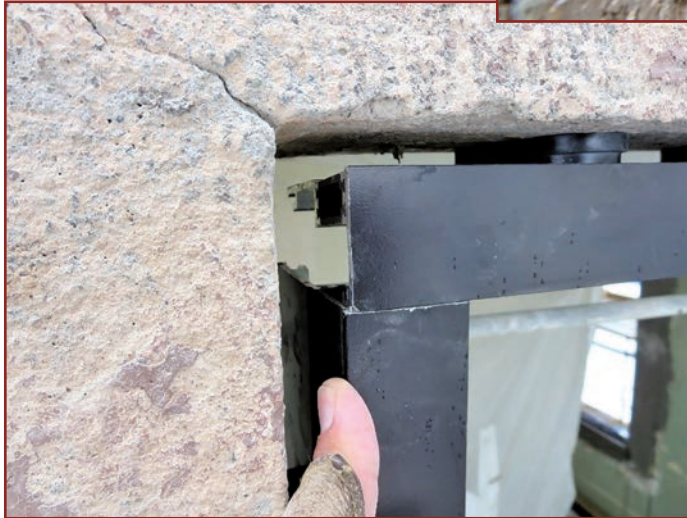
*Figure 13. An end cap installed at a gap between the head and jamb and fastened in place.*

If the window system has a head compensation channel, where the window frame is set into a separate head component, or if there is a gap at the head-to-jamb transition in the frame (Fig. 12), the exterior perimeter sealant will not have adequate surface adhesion area on the window frame for sealant adhesion. An end cap should be fabricated and installed in a full bed of sealant to cover the gap (Fig. 13).

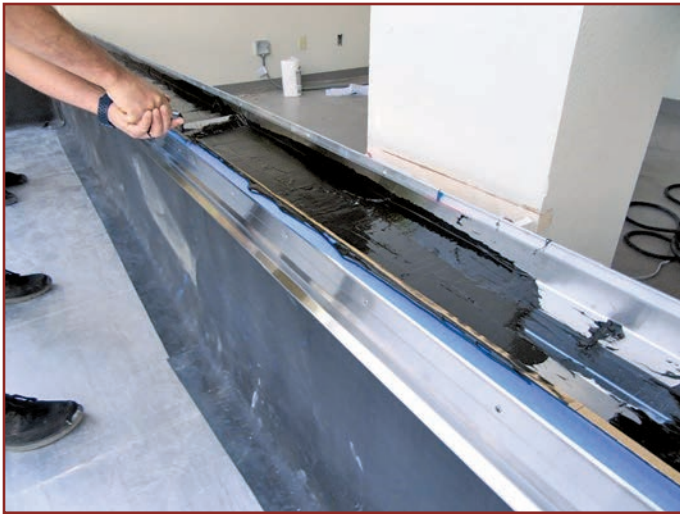
*Figure 15. Fluid-applied elastomeric waterproofing troweled in place between metal flashing components.*

that is mixed in the field and cures to a rubber-like material (Fig. 15). The back dam component can also be formed with membrane or fluid flashing installed over a vertical step formed in sill of the rough opening. Another advantage of this approach is that the back dam can be continuous along the entire run of the window frame at the interior. This is particularly useful when there is a stepped configuration (change in elevation) at the rough opening. An aluminum angle can be used to attach the vertical leg of the windowsill frame to the substrate; this will not penetrate the waterproofing below the window. After the waterproofing has cured, the windowsill is set into the two-component flashing system and then shimmed in place (Fig. 16). The shims below the sill provide a gap to allow for the installation of a continuous sealant joint between the windowsill frame and the drip edge of the sheet metal flashing with baffled weeps to allow for drainage.

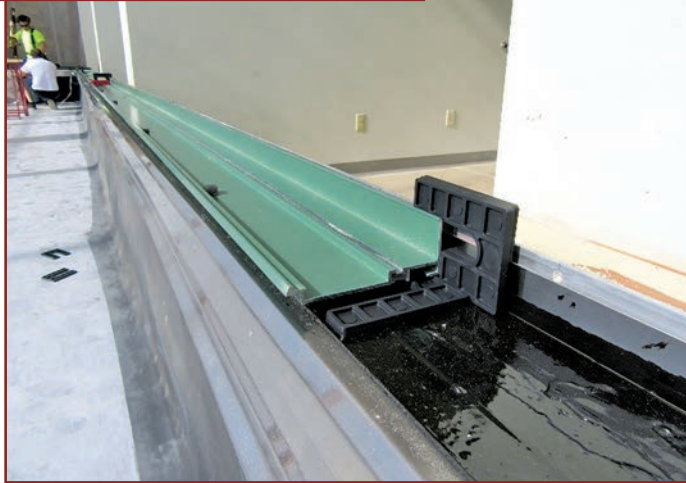
*Figure 16. A subsill set and shimmed in place.*

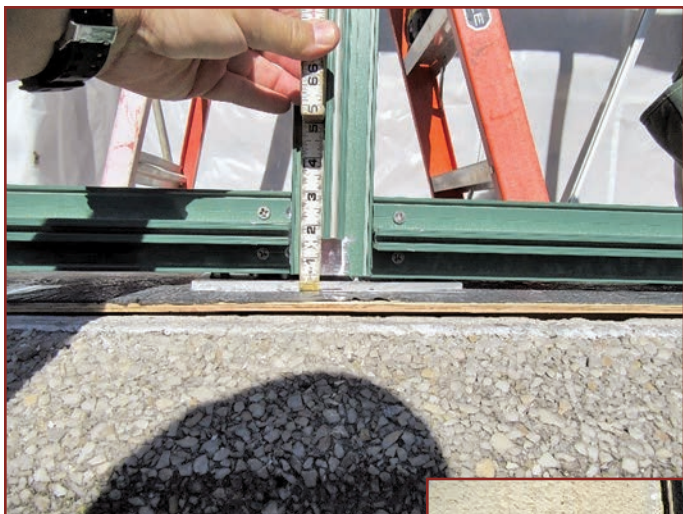
**Figure 18.** The portion of mullion tongue removed.

removed (Fig. 18 and 19). The metal flashing is fabricated to be continuous across the vertical mullion profile, which is the most vulnerable area of the system when attempting to install a continuous sealant joint between the mullion and rough opening.

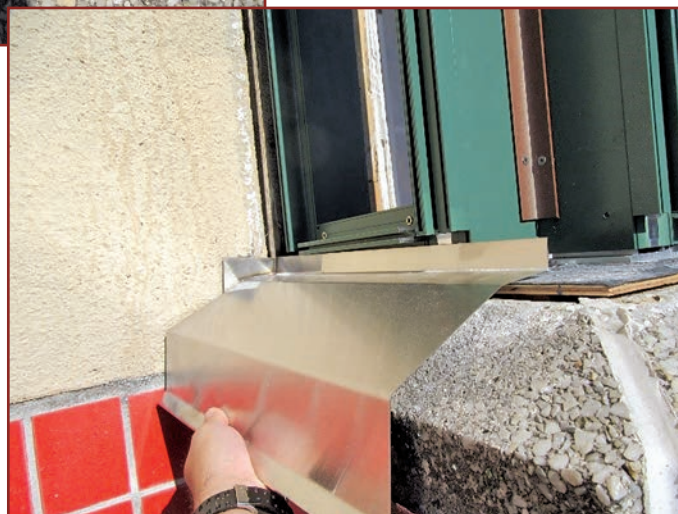
**Figure 19.** Supplemental flashing set into a glazing pocket under the mullion tongue.

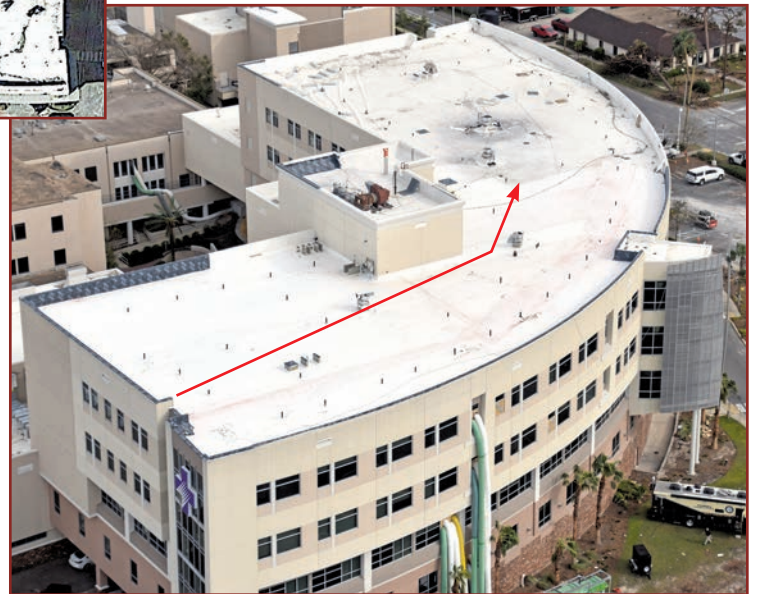
*Figure 2. By the time this photo was taken, the damaged roof membrane shown in Fig. 1 had been replaced (red line). In addition to roof membrane damage, rooftop equipment and exterior insulation and finish system were blown off.*
