# Proceedings

IIBEC 2022 - Building for the Future

# Proceedings of the IIBEC International Convention and Trade Show

# Nondestructive Testing Methods in Structural and Building Enclosure Assessment

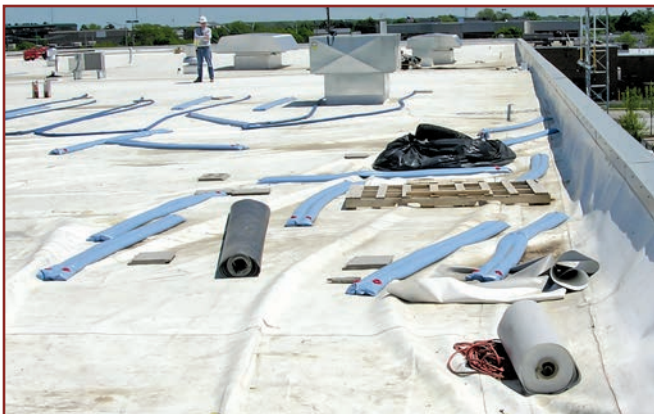
**Figure 3. Detached roof membrane on a new police station in the Midwest. The winds were well below the basic wind speed. Source: Federal Emergency Management Agency (FEMA P-2062).<sup>4</sup>**

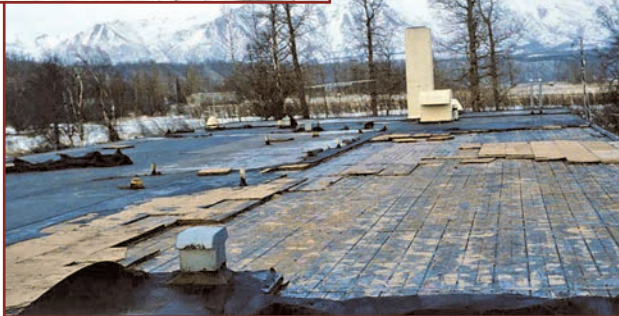
**Figure 4. The roof on this school in Palmer, Alaska, blew off during cold weather in the late 1970s, thus increasing the repair costs. Membrane lifting at the edge flashing initiated the failure. The membrane was not clamped by the metal edge flashing.**

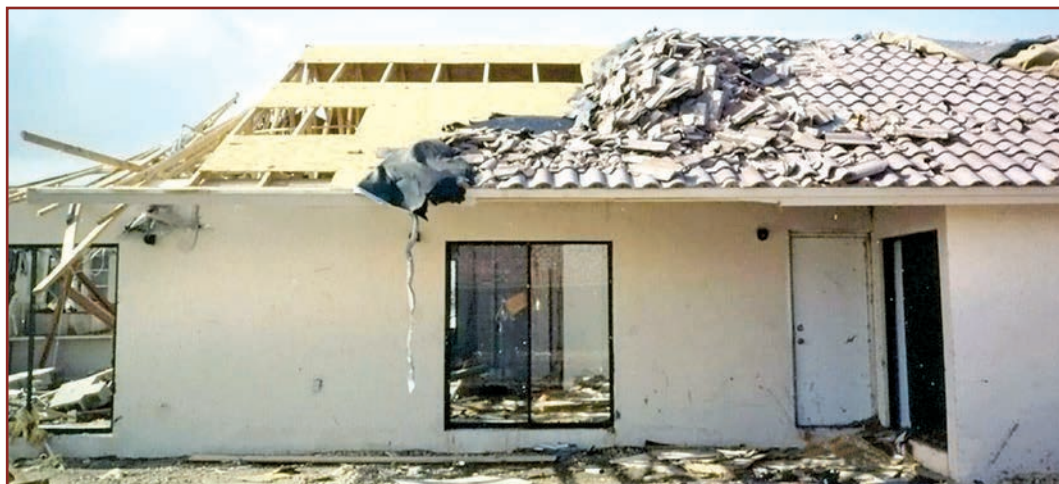
*Figure 7. Poor structural performance overshadowed the performance of the building enclosure.*

tial (Fig. 7) and nonresidential buildings. Fully engineered buildings typically did not experience structural damage (Fig. 8<sup>10</sup>).

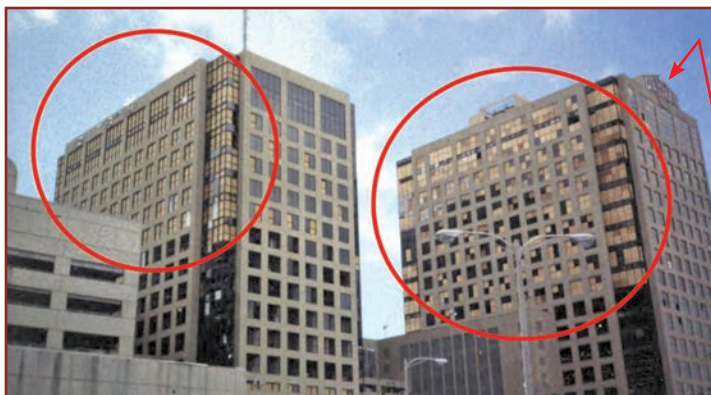
Figure 8. Most of the glazing in the red circles was broken by built-up roof aggregate. Further information on the glazing damage is given in Crandell and Smith.<sup>10</sup> This damage is reminiscent of glazing damage in the Houston, Texas, central business district during Hurricane Alicia (1993). The building on the right had a steep-slope roof; most of the mechanically attached single-ply membrane blew off. Estimated wind speeds were 145 to 170 mph.

Also as with Hurricane Hugo, Hurricane Andrew caused significant building enclosure damage (Fig. 8, 9,<sup>11,13</sup> and 10). In the area that received very high winds (from south of Kendall to Homestead), it was estimated that more than 95% of the low- and steep-slope roof coverings received some damage; more than 70% were estimated to be significantly damaged.<sup>12</sup>

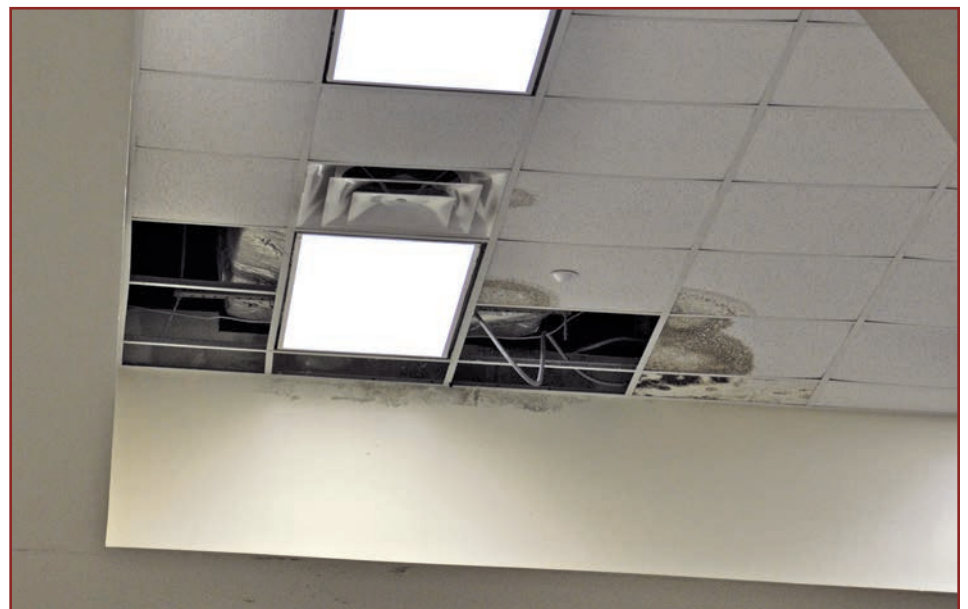
*Figure 14. During Hurricane Irma (2017), relatively minor roof damage resulted in leakage that collapsed acoustical ceiling panels and wetted carpet at a school auditorium in the US Virgin Islands. Source: Federal Emergency Management Agency (FEMA) Mitigation Assessment Team.*

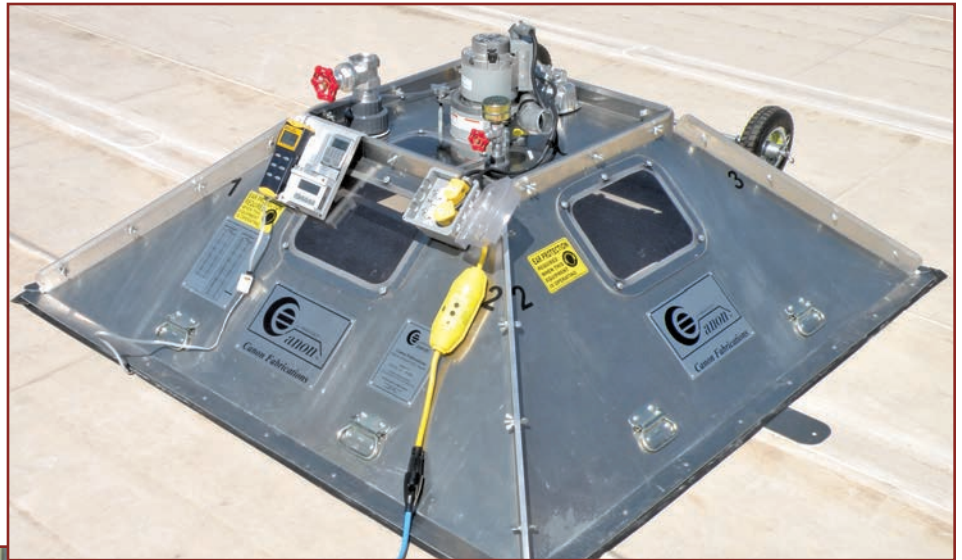
Figure 16. View of an exterior insulation and finish system field pull-test apparatus that is used with test method ASTM E2359.<sup>35</sup> Source: Federal Emergency Management Agency (FEMA P-2062).<sup>4</sup>

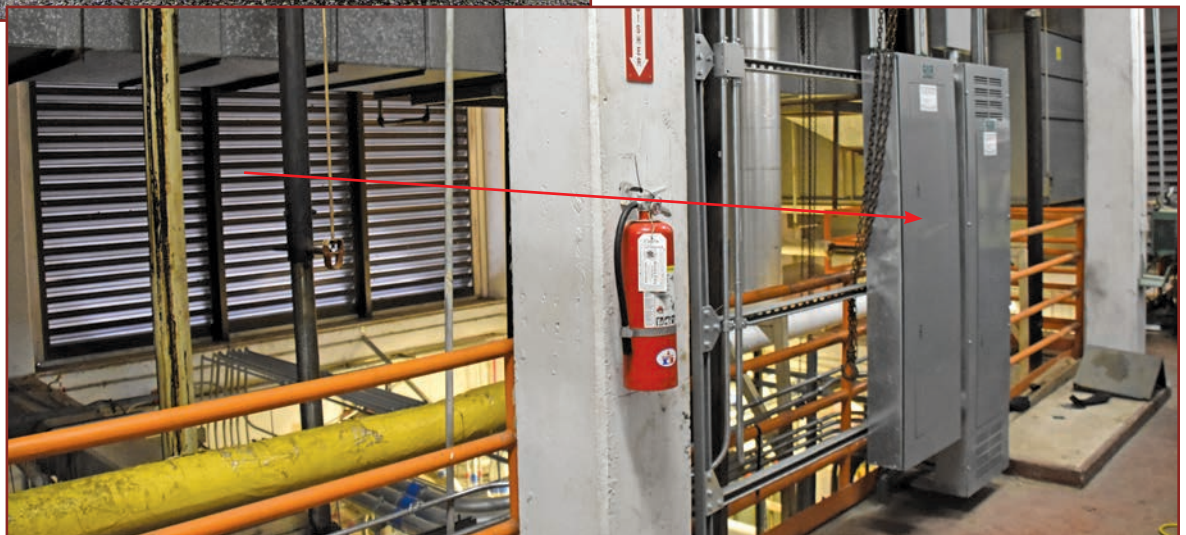
*Figure 18. Although the estimated wind speed at this Florida hospital was only 115 mph, rain was driven several feet past the louvers and wetted the electric panels, which caused the circuit breakers to trip. Source: Federal Emergency Management Agency (FEMA P-2077).<sup>1</sup>*

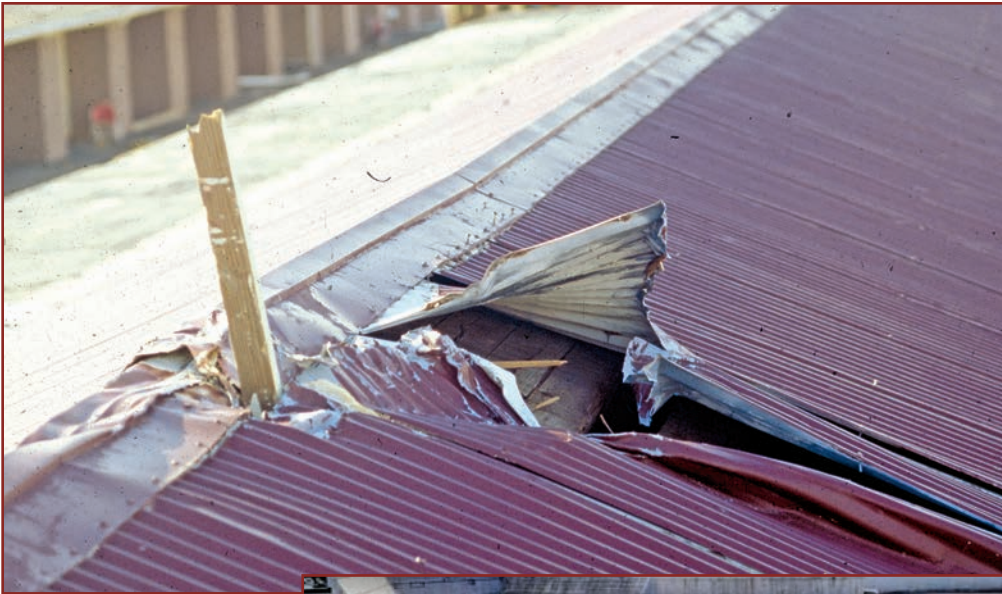
Figure 19. During Hurricane Marilyn (1995), a piece of 2x4 lumber penetrated the metal roof panel and 1x wood deck at a school in the US Virgin Islands. Source: Federal Emergency Management Agency Hazard Mitigation Technical Assistance Program.

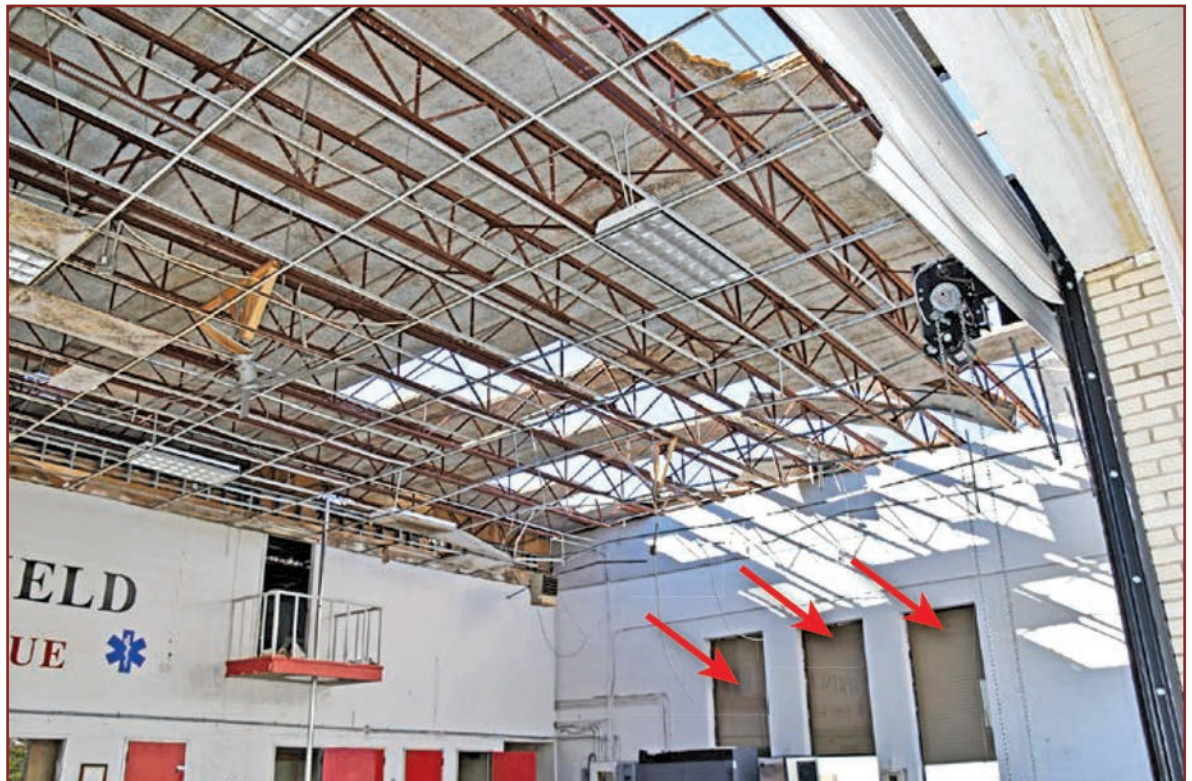
**Figure 21.** This Florida fire station was constructed in 1978. Around 2001, it was retrofitted with storm shutters (red arrows) and new apparatus bay doors (which failed during Hurricane Michael in 2018). These mitigations were unsuccessful because several of the cementitious wood-fiber deck panels blew off. The fire station was demolished after the storm. The ASCE 7-16<sup>2</sup> basic wind speed for this building is 146 mph. Estimated wind speed was 132 mph (90% of the basic speed). Source: Federal Emergency Management Agency.<sup>46</sup>

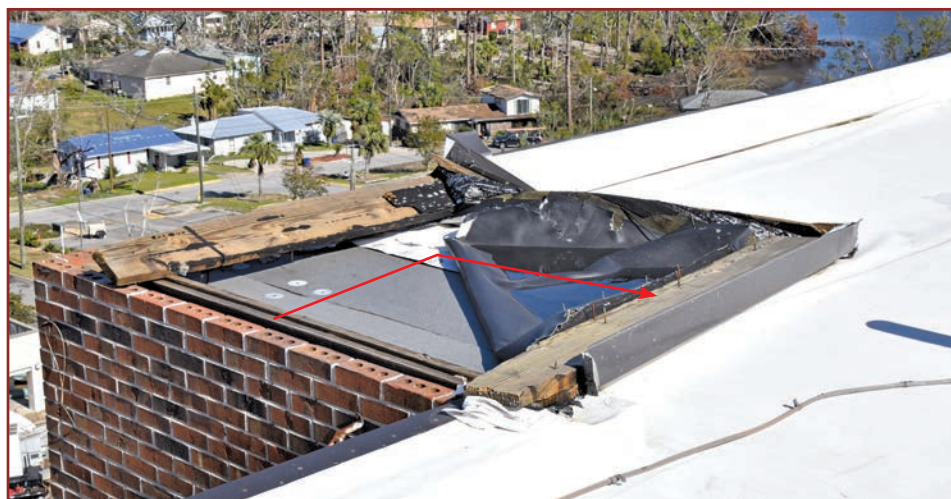
Figure 24. During Hurricane Michael (Florida, 2018), the nailer lifted and caused progressive lifting and peeling of the roof membrane. The ASCE 7-16<sup>2</sup> basic wind speed for this building is 147 mph. Estimated wind speed was 130 mph (88% of the basic speed). Source: Federal Emergency Management Agency (FEMA P-2021).<sup>1</sup>

Figure 24<sup>1</sup> illustrates the importance of conducting a comprehensive vulnerability assessment. The nailer at this medical office building had inadequate wind resistance. The nailer was part of the original construction, but its attachment was apparently not checked when the building was reroofed. FEMA<sup>4</sup> provides guidance for assessing nailer attachment, and Smith<sup>49</sup> provides design guidance for existing nailers.

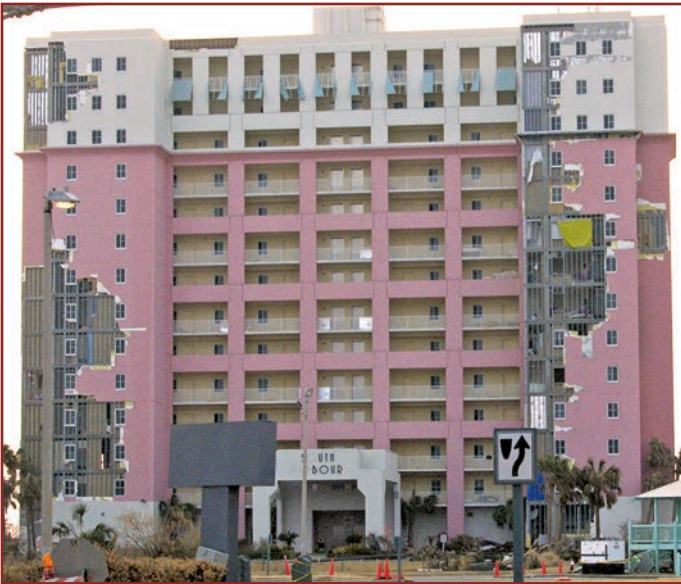
Figure 25. Damage that occurred during Hurricane Ivan (Alabama, 2004) to an exterior insulation and finish system (EIFS) at a residential building. The gypsum board typically detached from the studs. In some areas, the interior gypsum board was also blown off. EIFS can perform well, but wind damage is common. (EIFS damage also occurred at the hospital shown in Fig. 2.) Use of precast concrete wall panels would be a conservative design enhancement. Source: Federal Emergency Management Agency (FEMA 489).<sup>52</sup>

hazard where the building is located and the owner's desired level of resilience. Figures 25 and 26 illustrate the importance of design enhancements and inspection during construction.

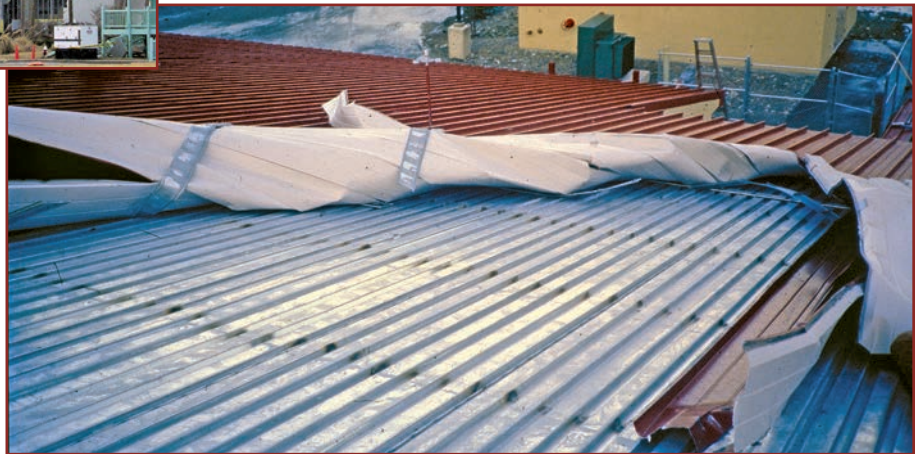
Figure 26. In the mid-1980s, the roof on this new school in Anchorage, Alaska, blew off during moderate winds soon after it was installed. It failed even though it was a robust system because of a major installation error.

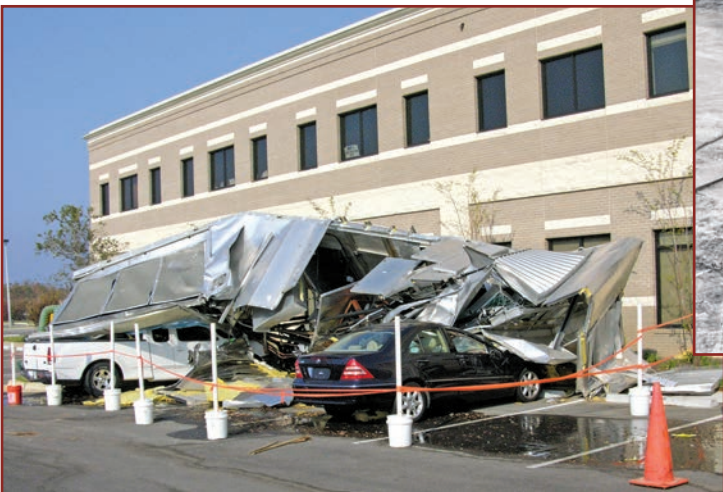
Figure 27. Although this 18,000-lb heating, ventilation, and air-conditioning unit was attached to its curb with 16 straps, the unit blew off during Hurricane Ivan (2004) because the attachment was inadequate. The Alabama medical office building was less than one year old. The estimated wind speed was 85 to 95 mph. Source: Federal Emergency Management Agency (FEMA 489).<sup>52</sup>

Islands (2017) and Fig. 27<sup>52</sup> and 28<sup>1</sup> illustrate rooftop equipment performance problems.

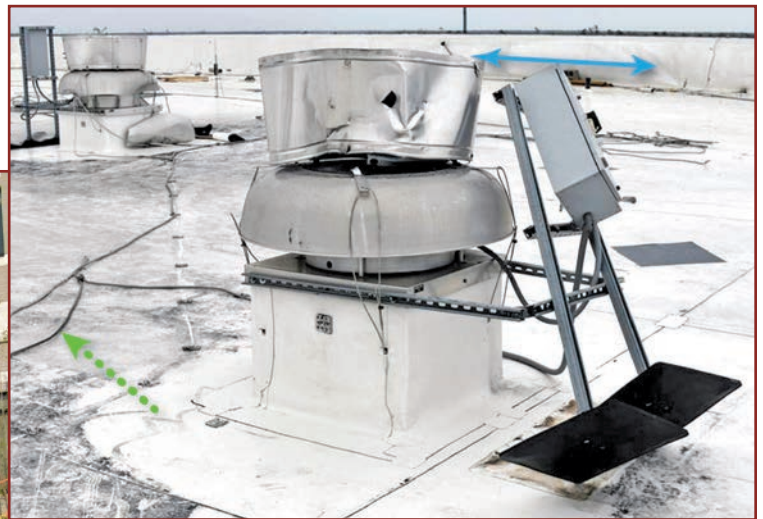
Figure 28. The fan in the foreground was struck by wind-borne debris. The fan's disconnect switch bracket was not adequately anchored. The green dotted arrow indicates a detached lightning protection system conductor. The blue arrow indicates detached base flashing. This damage occurred at the Florida hospital shown at Fig. 2 during Hurricane Michael (2018). Source: Federal Emergency Management Agency (FEMA P-2077).<sup>1</sup>

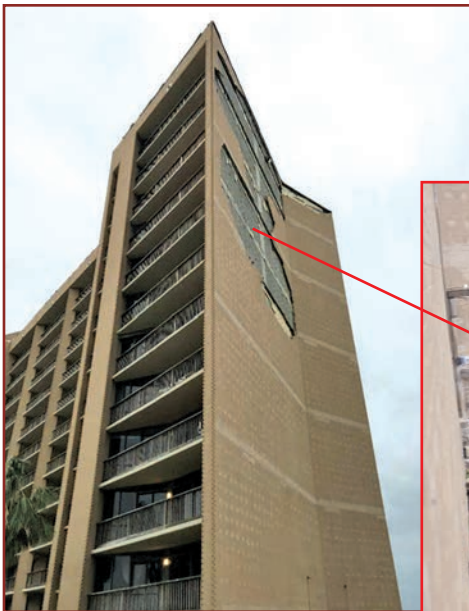
*Figure 29. Brick veneer failure at a 12-story Texas condominium during Hurricane Harvey (2017). Before the storm, repairs had been made in the failed area using helical ties. The ASCE 7-16<sup>2</sup> basic wind speed for this building is 149 mph. The estimated wind speed was 140 mph (94% of the basic speed). Source: Federal Emergency Management Agency (FEMA P-2022).<sup>40</sup>*

Appropriate design and installation are needed to avoid failures such as the example shown at Fig. 29.<sup>40</sup>

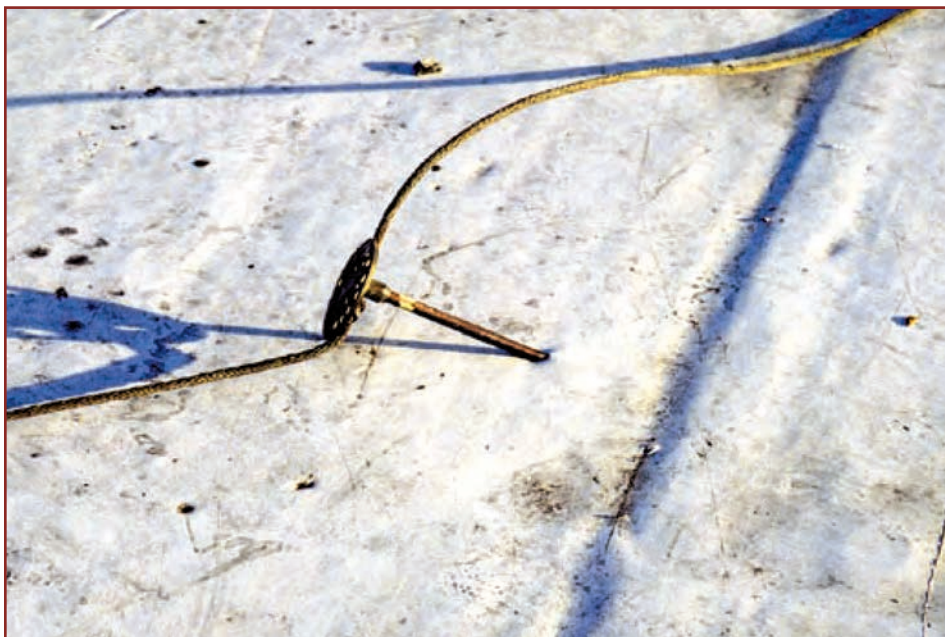
*Figure 30. During Hurricane Marilyn (US Virgin Islands, 1995), a displaced air terminal punctured the roof membrane in several locations. Source: Federal Emergency Management Agency (FEMA 543).<sup>2</sup>*

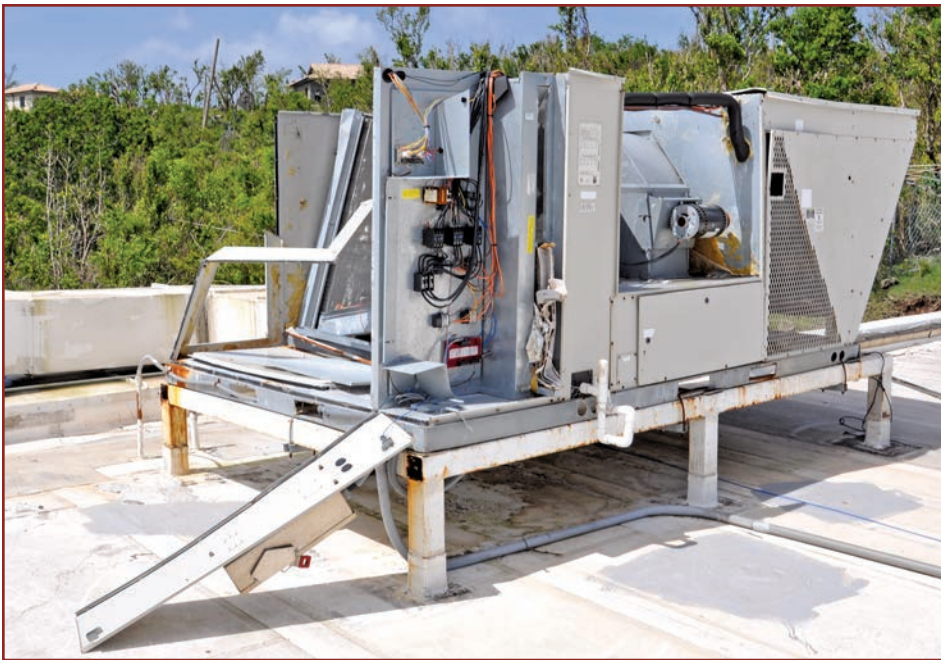
**Figure 31.** The sheet metal enclosure (cabinet) blew off this heating, ventilation, and air-conditioning unit during Hurricane Irma (US Virgin Islands, 2017). An access panel was also blown off. It appeared that wind-blown enclosure debris caused roof membrane tears. Source: Federal Emergency Management Agency (FEMA P-2021).<sup>57</sup>

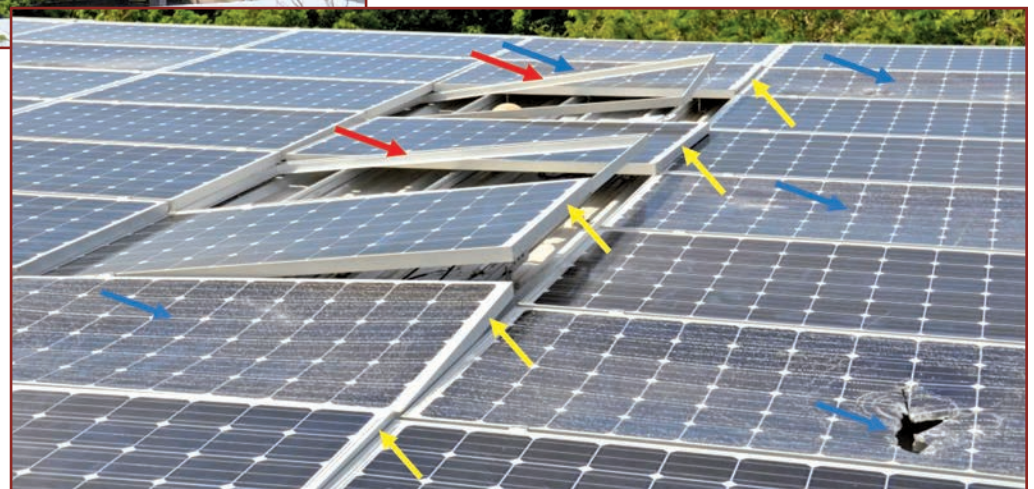
**Figure 32.** The red lines indicate where several adjacent solar panels were blown off during Hurricane Irma (US Virgin Islands, 2017). The area within the red oval in the left photo is the focus of the right photo, where the red arrows indicate the polyvinyl film detached from the panel frame. Some panels lifted but did not blow away (yellow arrows). Some panels were damaged by wind-borne debris (blue arrows). Source: Federal Emergency Management Agency.<sup>25</sup>

needed to avoid poor wind performance. For example, when Hurricanes Irma and Maria struck the US Virgin Islands in 2017, many rooftop solar panels exhibited poor wind performance (Fig. 32<sup>25</sup>). (For information on design, installation and maintenance guidance for rooftop solar panels, see FEMA's *Recovery Advisory*.<sup>25</sup>)

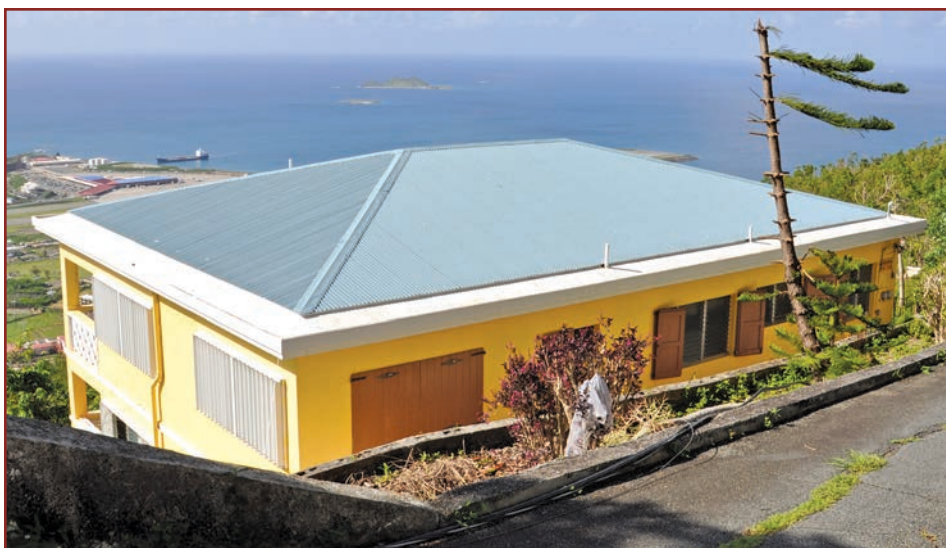
**Figure 33.** During Hurricane Irma (US Virgin Islands, 2017), there was no apparent damage to this building enclosure (the interior was not evaluated for entrance of wind-driven rain). The estimated wind speed was approximately 175 mph (including wind speed-up due to an abrupt change in topography). Source: Federal Emergency Management Agency (FEMA P-2021).<sup>57</sup>

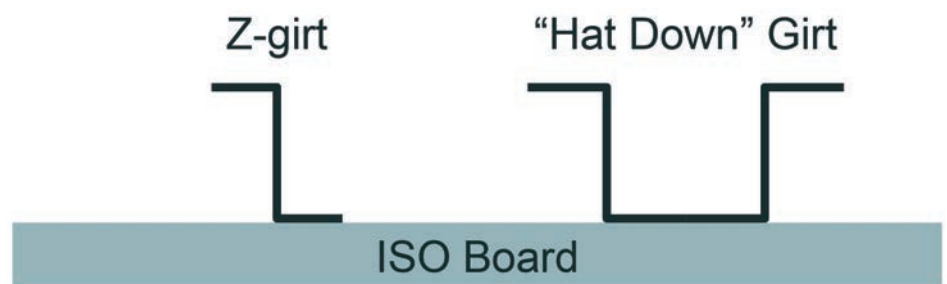
Figure 1. Z-girt and “hat down” girt connect to the sheathing in the same way.

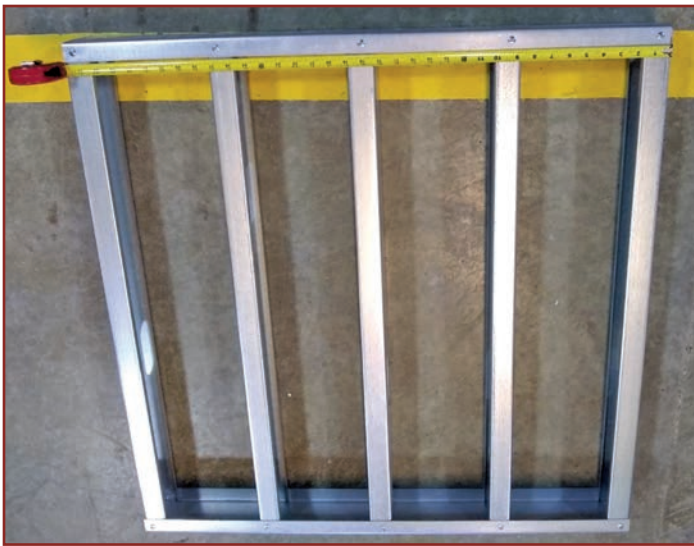
(a) Make steel stud frame

Figure 3. Step-by-step process to make a wall.

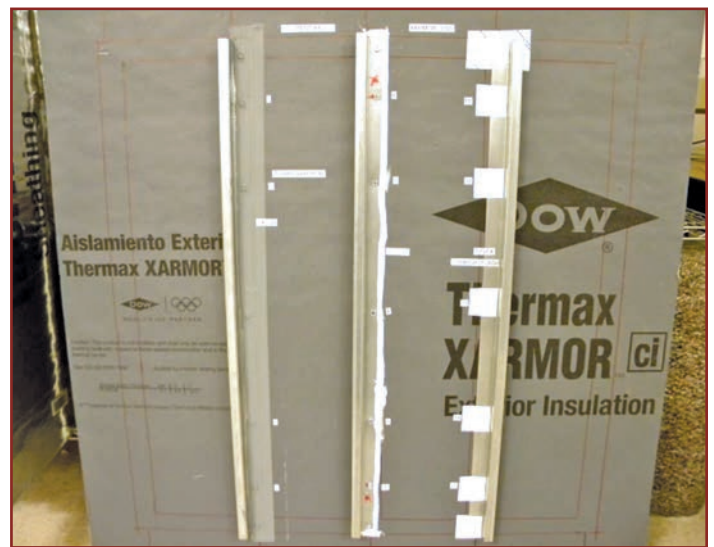
(d) Attach girts and flashing as per test plan

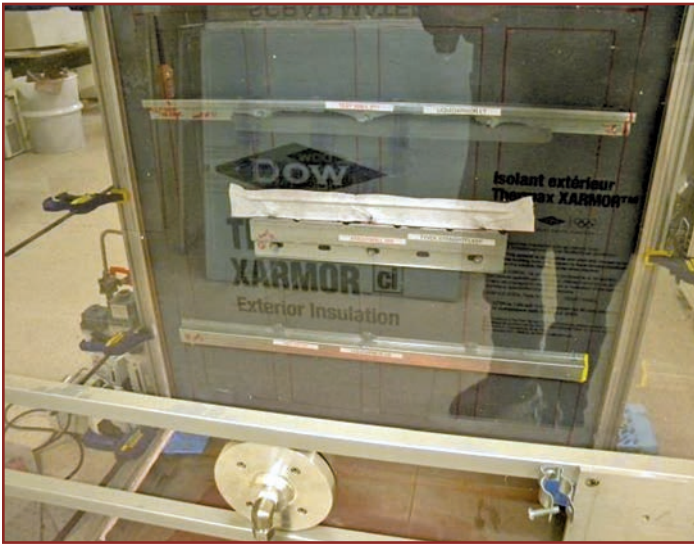
(a) Wall inside test frame: front view

After the flashing cured, the wall was transferred into a small chamber equipped with a vacuum pump and spray head. Water was sprayed on the entire wall under the pull of vacuum pressure. Water was sprayed at a rate of 5.0 US gal/ft<sup>2</sup>·hr (3.4 L/m<sup>2</sup>·min) per the standard. It was sprayed for two hours under a negative pressure of 6.24 lb/ft<sup>2</sup> (300 Pa) per ICC-ES AC71.<sup>6</sup> The vacuum pressure was then increased to 15 lb/ft<sup>2</sup> (720 Pa) for an additional 15 minutes, which is similar to the testing done on many window systems. While the higher vacuum pressure is greater than what is tested for most WRBs, it is in line with the pressures required of windows being tested to the same standard. If fasteners did not leak during the entire protocol, they were recorded as a pass.

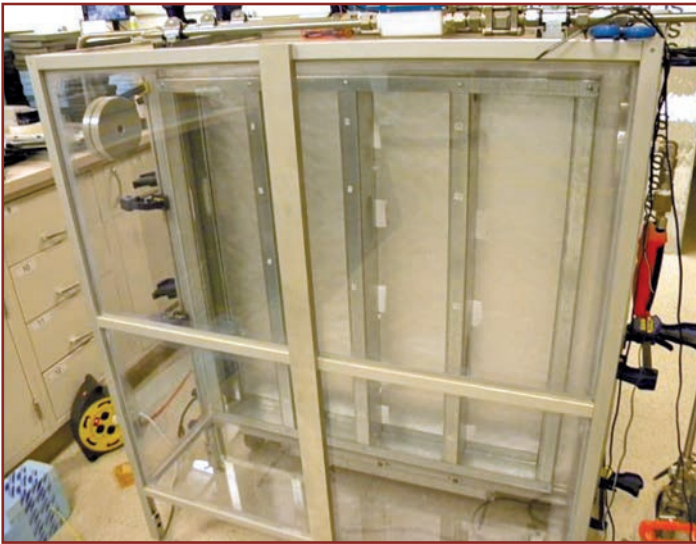
(b) Wall inside test frame: back view

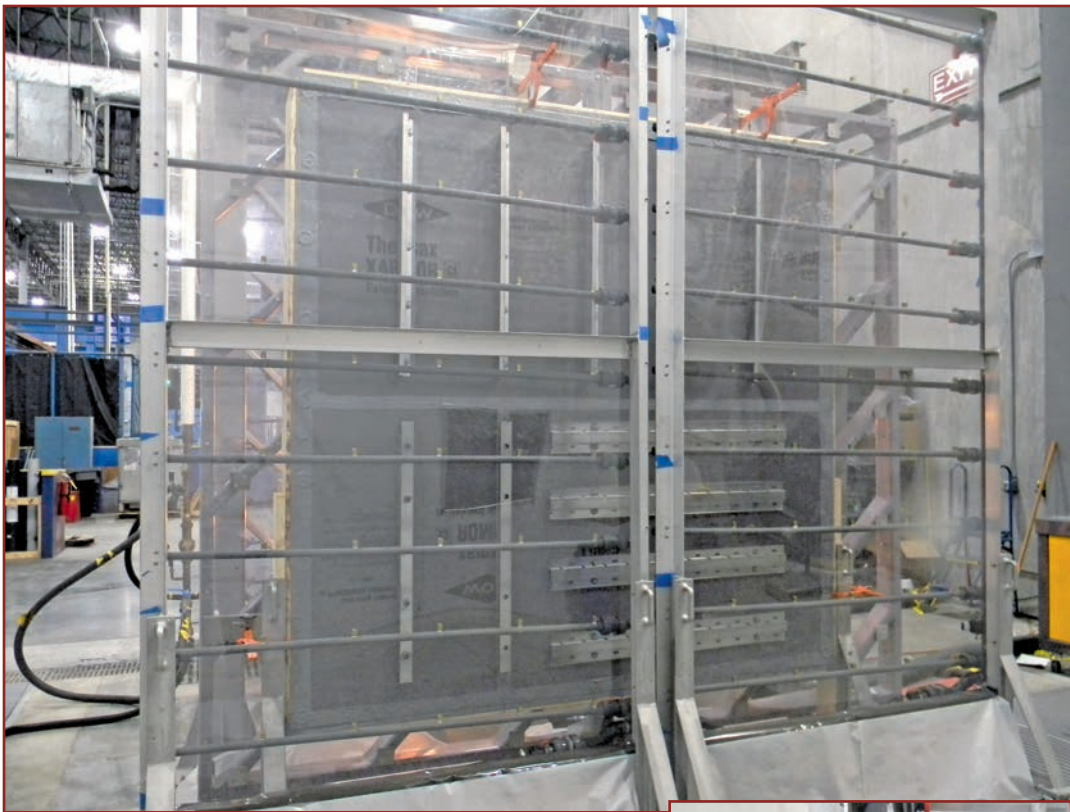
Figure 7. Wall shown in the test setup. Various girts are attached with different flashing configurations. A spray rack is in front of the wall.

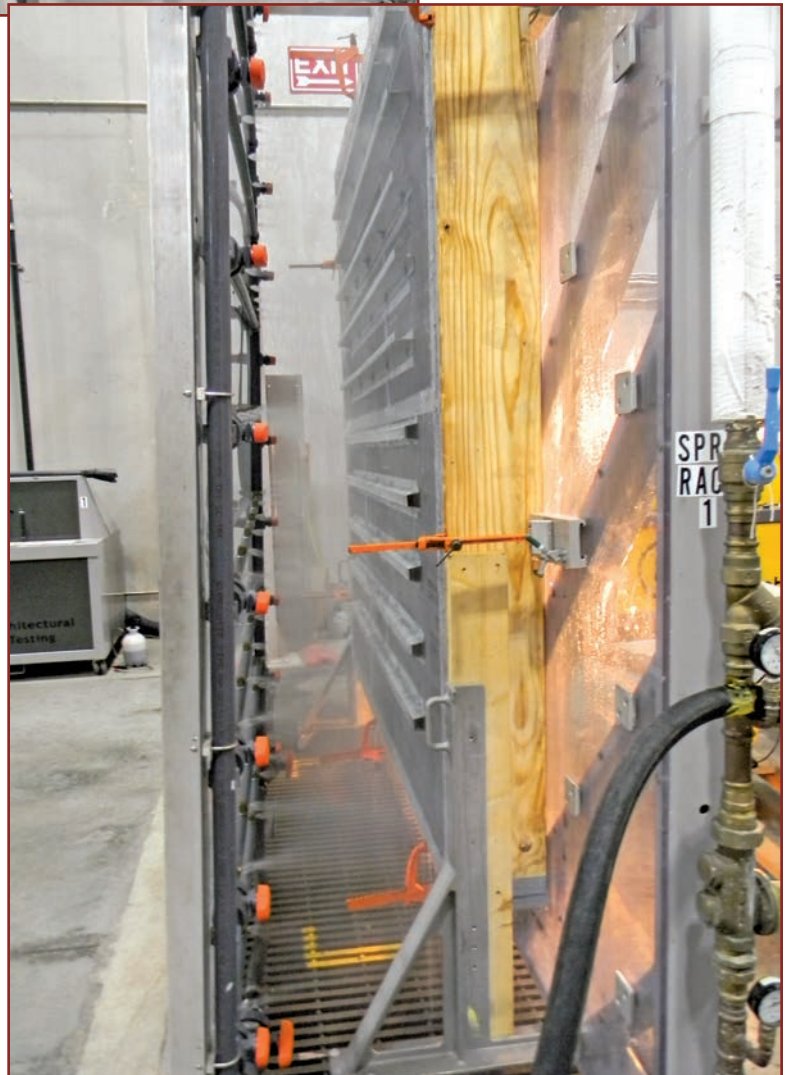
Figure 8. Side view of the wall during test. Water is seen coming out of various nozzles on the spray rack.
