Technical Advisory Bulletin

To: GAF Residential Sales, GAF Contractors, Field Services, AIS, CARE
From: Technical Services
No: TAB-R-109

Exposed Nails On Shingles

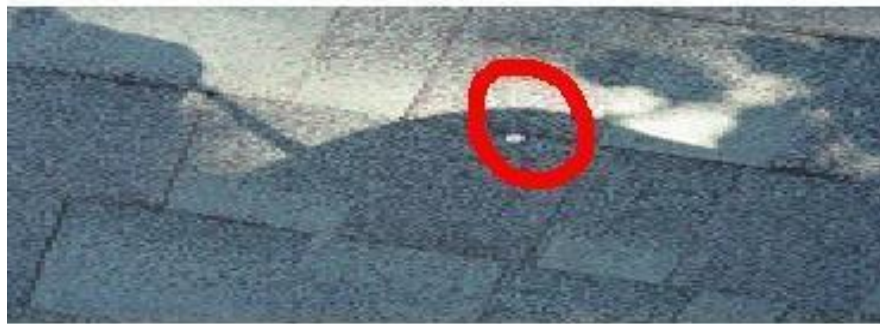
Nails directly exposed to the environment... are called “exposed nails” or “exposed fasteners”. These can be seen by close visual inspection of the roof materials as well as possibly by virtue of reflections. Because these are sometimes noticed by reflection of sunlight, exposed nails are sometimes referred to as “shiners”.

Fasteners/Nails installed on the face of the shingle... or below the fastening line results in exposed nails. When shingles are installed following GAF’s application instructions, there will be no exposed nails in the field of the roof.

Exposed nails can corrode over time... and can allow water infiltration. Additionally, as shingles move over time due to slight deck movements, expansion and contraction due to temperature variations, wind, etc, the hole the nail is in may enlarge, allowing water to enter.

Replace face-nailed shingles... Remove any shingle with exposed nails in it and replace it with a new shingle. Any type of roof cement or caulk used as a method of repair is not considered as a permanent repair. This method of repair is an exclusion from coverage.
