TopCoat® - H&H Firearms Fort Wayne, IN

Key Project Profile

WallCote™ Protection System Stopped the Leaks H&H Firearms FORT WAYNE, INDIANA

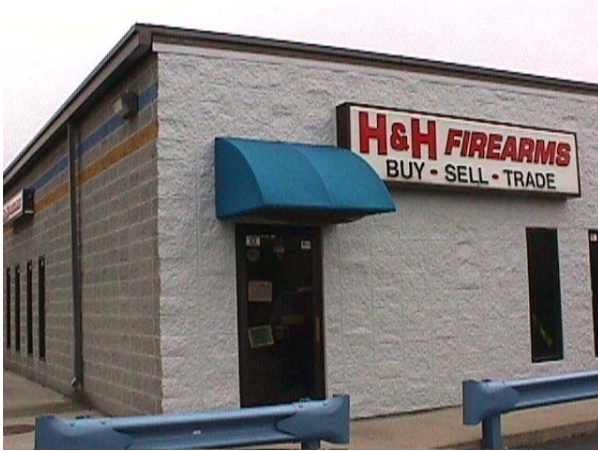
- Block building has endured leaking problems since 1985
- Previous attempts to waterproof the block walls had failed
- Retail owner has had severe water damage to the interior of his building over the years
- Maintain the aesthetic value of the highly visible retail building
- No interruption of tenant's day-to-day business (or fumes) was acceptable

- **WallCote™ Exterior Wall Protection System using WallCote™ Block Primer and WallCote™ Elastomeric Wall Coating in Stone Gray**
