Technical Advisory Bulletin

To: GAF Residential Sales, GAF Contractors, Field Services, AIS, CARE
From: Technical Services
No: TAB-R-116

Ice Dams... Their Cause And Preventative Measures

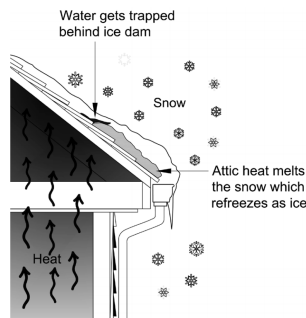
Figure 1

An ice dam... is a build-up of ice at the eave that may eventually back-up water under the shingles. When snow on the roof melts, the water travels down the roof and freezes when it passes over the unheated eave. As the water continues to flow, it becomes blocked by the newly formed "ice dam". This water then freezes, and the cycle continues. As more water freezes, it begins to back-up under the shingle tabs. As this continues further up the roof, the warmer attic space may prevent the water from freezing and this water may enter the house. **Fig. 1**

- 1. The first measure...** is to install a leak barrier such as StormGuard® or Weather Watch® Leak Barrier. These membranes help to prevent water from entering through the roof deck.
 - Ice dam protection is required by most codes in northern climates and should be installed at a min. of **24"** beyond the **"warm wall"** of the house noted in **Fig. 2**.
 - Additionally, for added protection, leak barriers should be installed at areas as noted in **Fig. 3**.
- 2. The second measure...** is proper ventilation. Heat, moisture and condensation build up under roof decks.
 - GAF recommends a continuous, balanced soffit and ridge system that meets the **FHA/HUD-1/300 rule** that calls for 1 sq. /ft. of net free ventilation per 300 sq. ft. of attic floor space.
 - Adequate ventilation can lower the temperature of the attic, which will reduce the melting of snow of the roof surface.

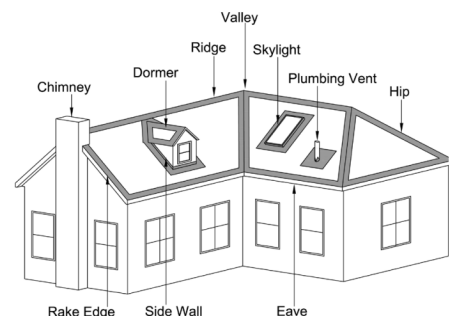
Figure 3

For a leak barrier... Weather Watch® or StormGuard® underlayment can be used as the eave protection membrane. These membranes can be installed at the areas as shown in **Fig. 3** as well.

The latent damage from ice dams may not be immediately evident. For example, insulation could be getting wet and over time will lose its ability to perform properly. In addition, mold may begin to grow in the moist attic environment. Although ice dams are more prevalent at the eaves, they can (and do) occur anywhere on the roof, especially where there is a change in roof surface temperatures. These areas need special consideration by roofers, specifiers or builders.
