TECHNICAL ADVISORY BULLETIN

Subject: Installed Nails MUST BE Flush to the Surface without Protrusions

No: TAB-R 2012-162

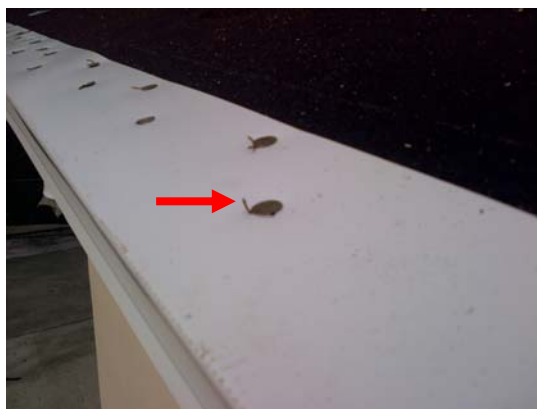
The residual metal "hair" that is left on some nails after being shot from a pneumatic coil nail gun can stick up and cause damage to your newly installed roof.

As shown in the figure below, the metal "hair" can be long and sharp enough to puncture or cause damage to installed asphalt shingles.

Residual metal "hair" at drip edge

- Switch to another type of pneumatic nail that does not leave the residual metal "hair" that sticks up.
- Hammer the "hair" left on the installed nails flush to the surface so that nothing will puncture or damage what is being installed on top.
- Notify your fastener manufacturer, supplier and/or local code authority if you are encountering this issue.
